**The Buzzards Bay Stormwater Collaborative
Illicit Discharge Investigation Trailer**

Town of Mattapoisett Report

July 2021

Mattapoisett IDDE Report

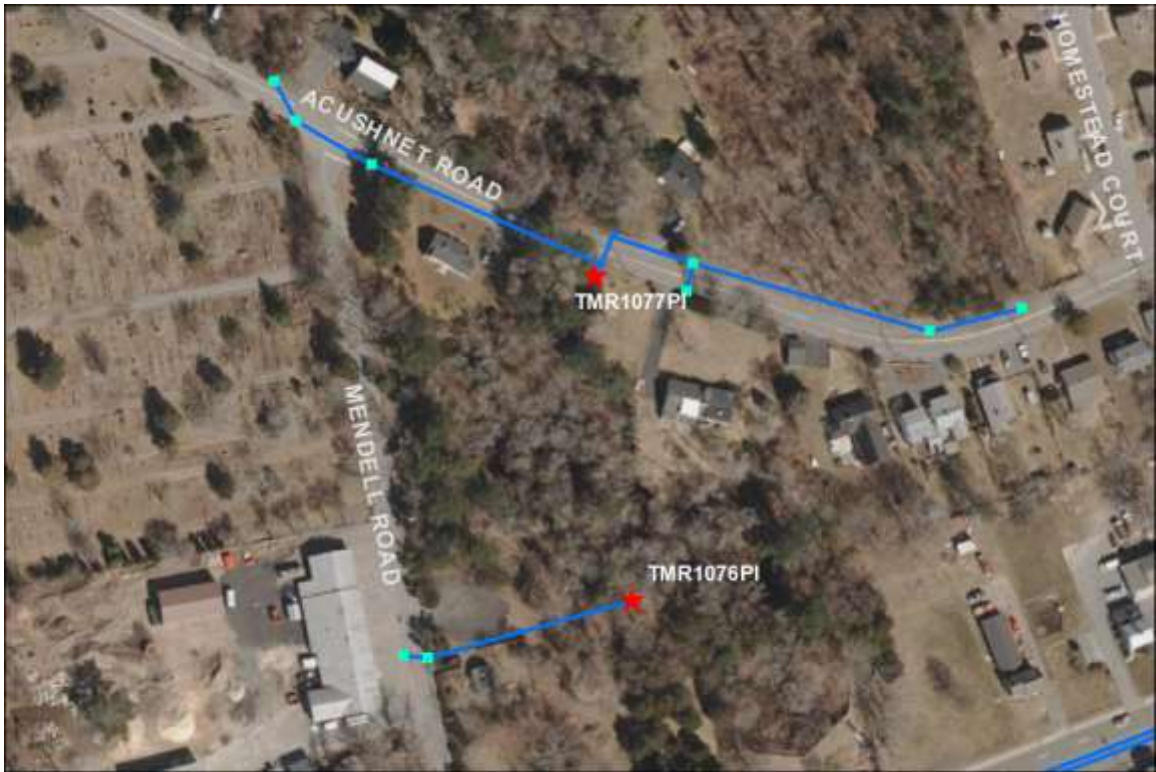
TMR1076PI – Mendell Road: no issues found; note that vehicle washing in front of the DPW garage will enter this system, recommend avoiding the use of detergents and address spill prevention. TMR1077PI – Acushnet Road: no issues found; the pipes from both directions enter into the culvert for Tub Mill Brook.

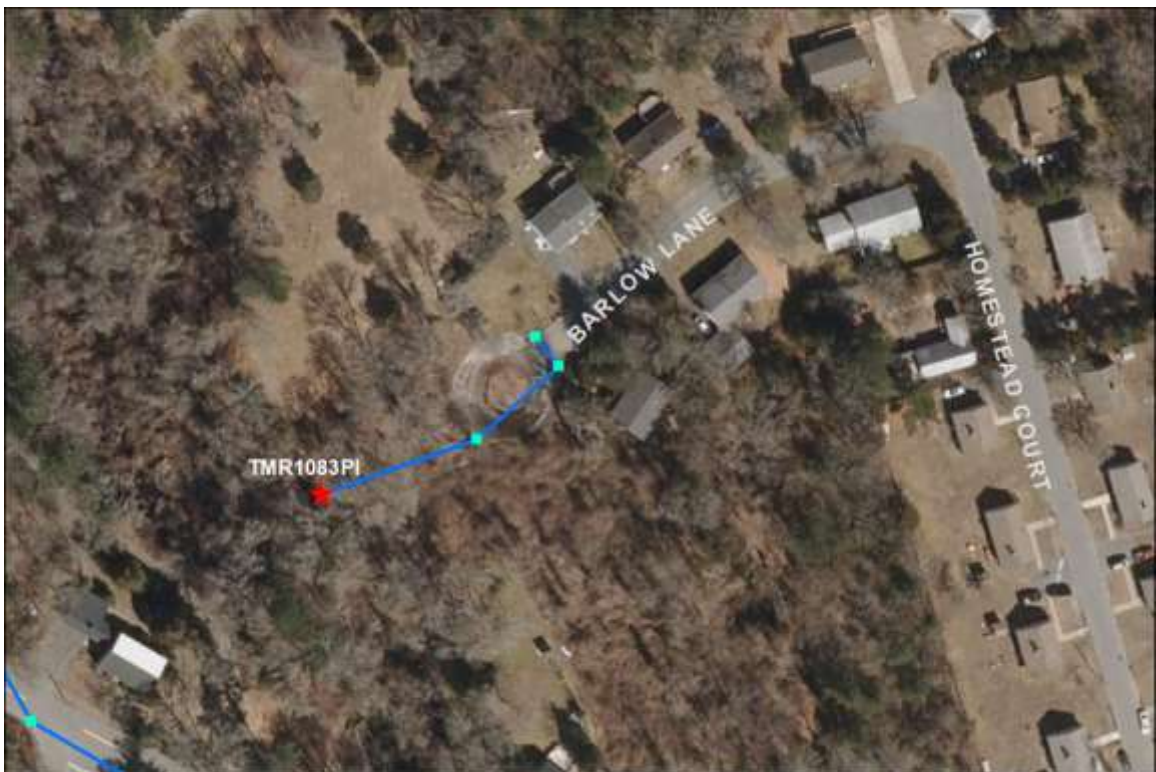
TMR1083PI – Barlow Lane: private road; outfall pipe could not be found; structures are in poor condition; recommend that the owner be compelled to repair structures.

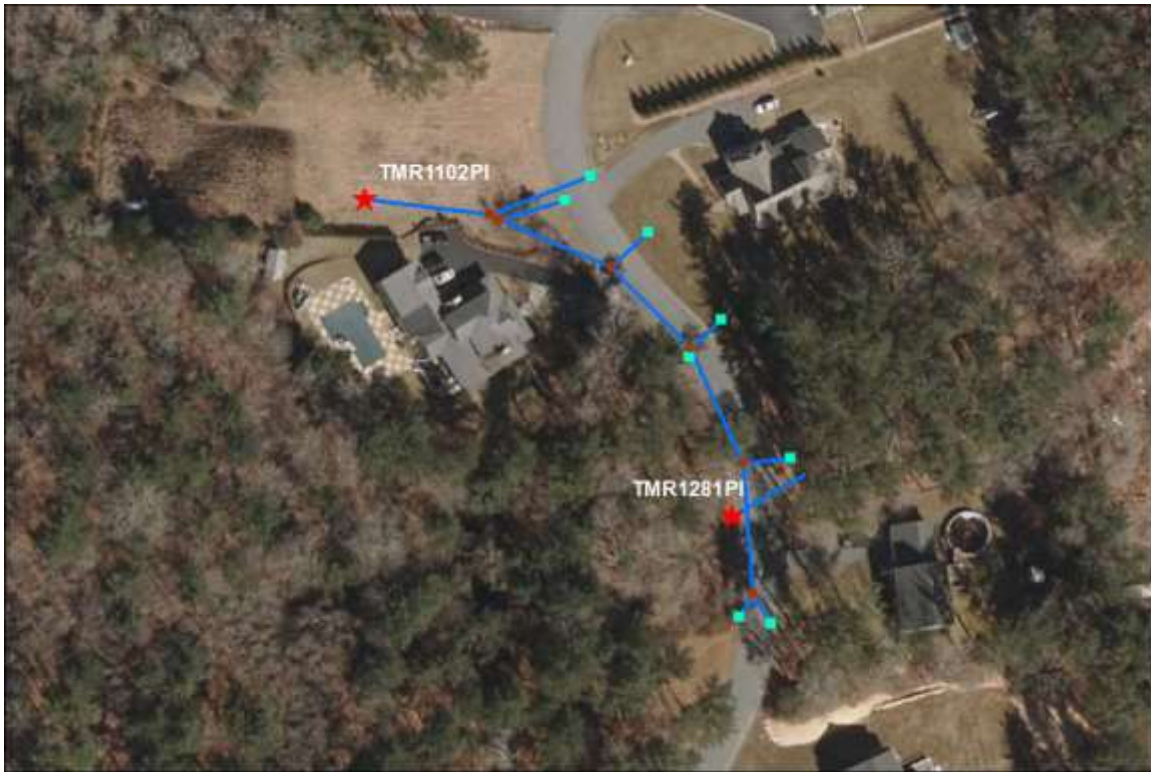
TMR1102PI and TMR1281PI – Park Place: no issues found; the system includes structures to retain high flows; the outfall was recently moved to accommodate the construction of another home; some catchbasins in this area require cleaning.

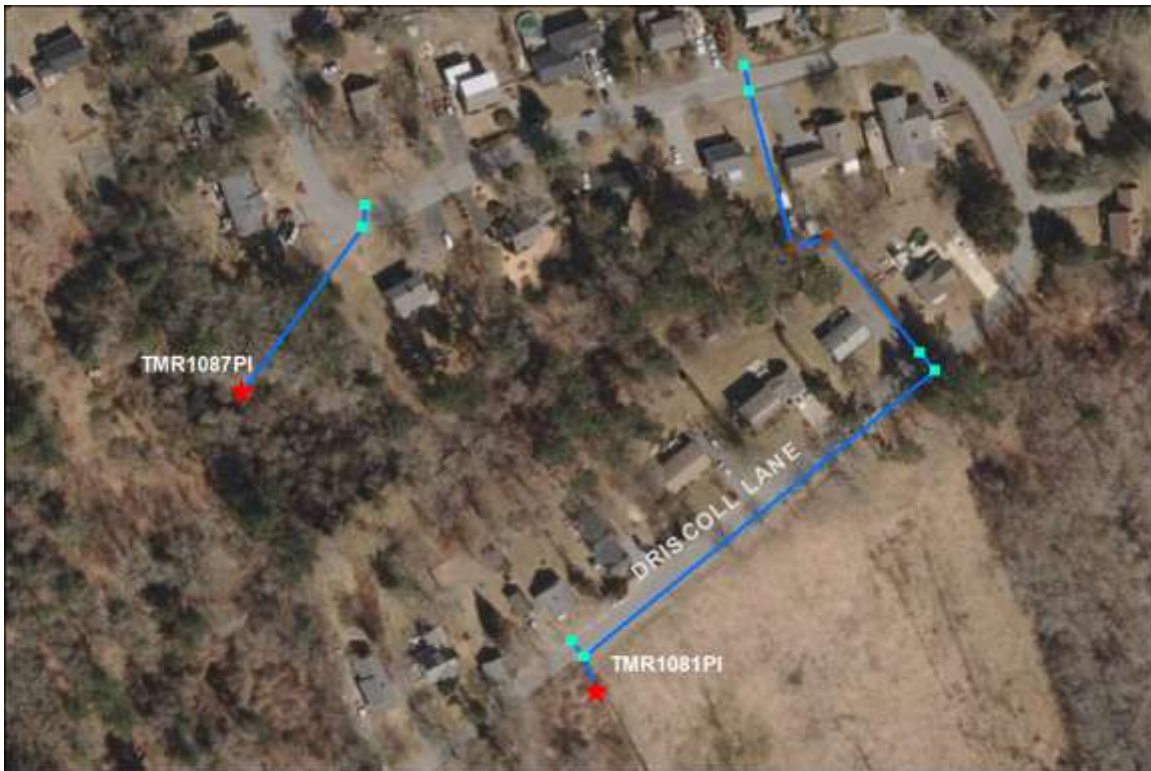
TMR1087PI and TMR1081PI – Driscoll Lane: no issues found; the two manhole junctions shown behind homes have concrete covers and could not be inspected; several sump pump drains were observed but none were flowing; the ground water flow at outfall TMR1081PI was tested for detergents but none were detected.

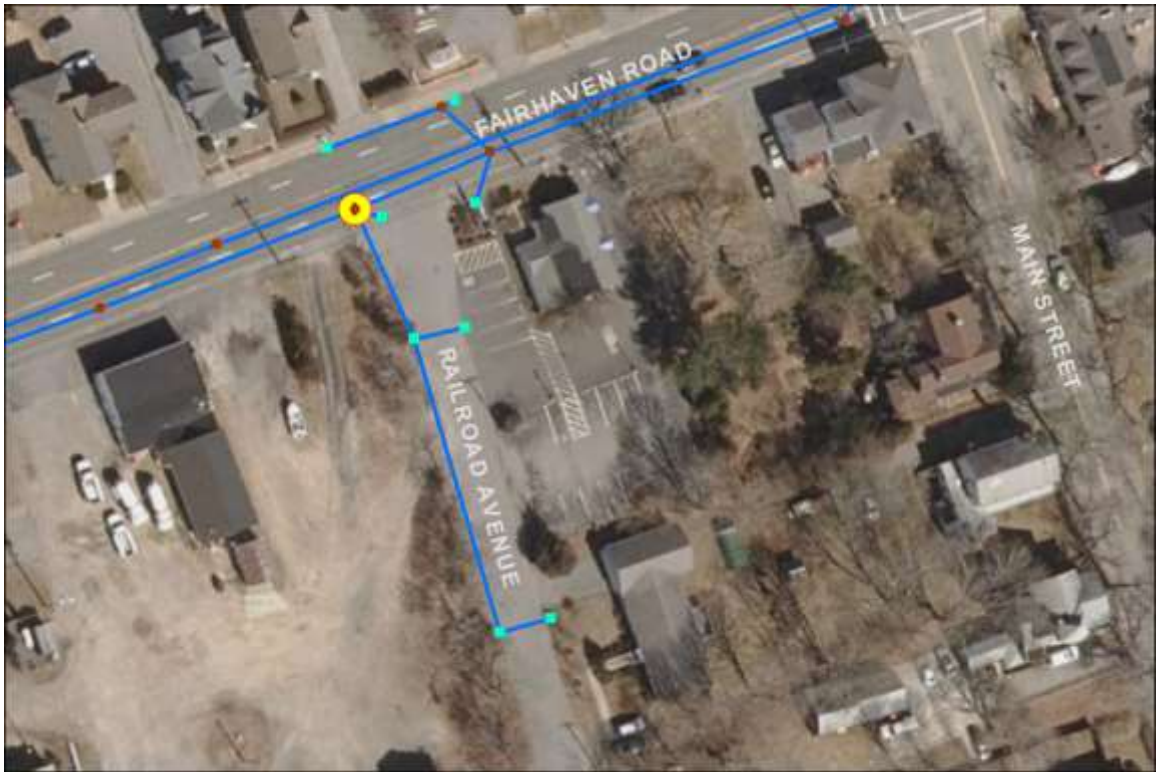
Railroad Avenue: no issues found; the activities to the West could be industrial and impact these catchbasins; recommend testing sumps for evidence of oil; these structures drain to an interconnection on Route 6.

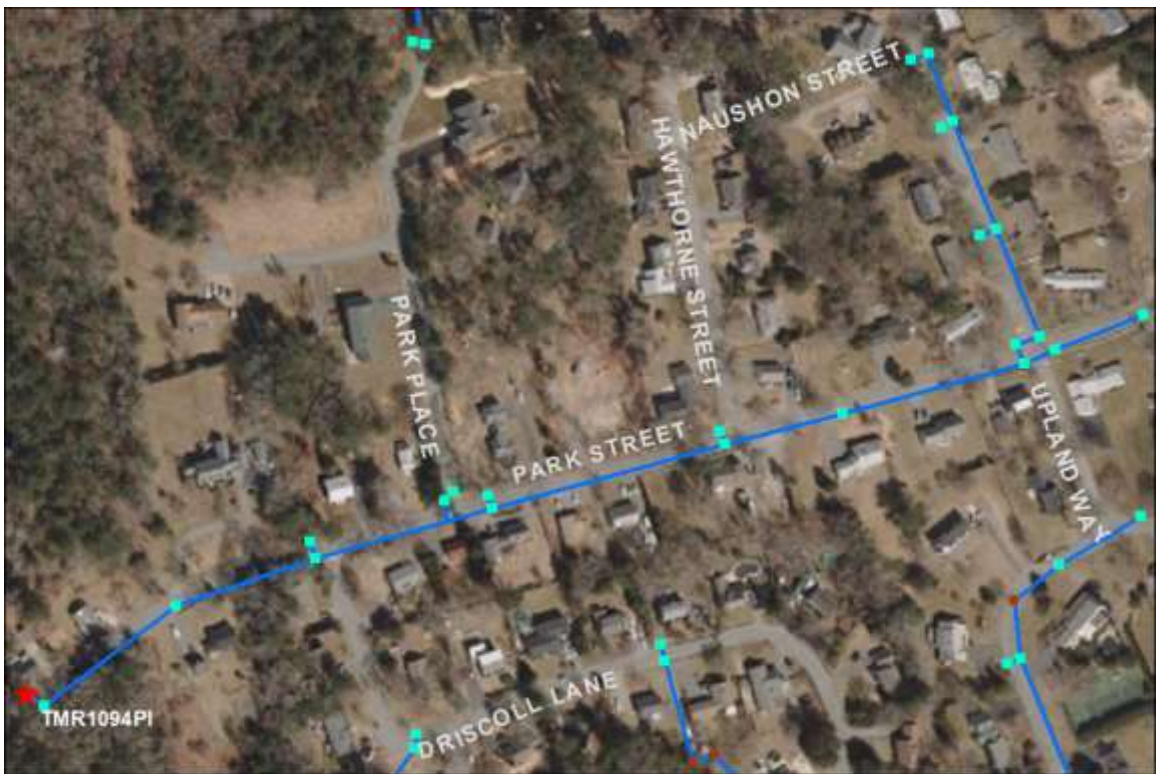
TMR1094PI – Park Street: no issues found; this large network drains into a channel at 17 Park Street and will also drain into the wetland across the street; the wetland flows in the direction of the channel when no storm flow is present.

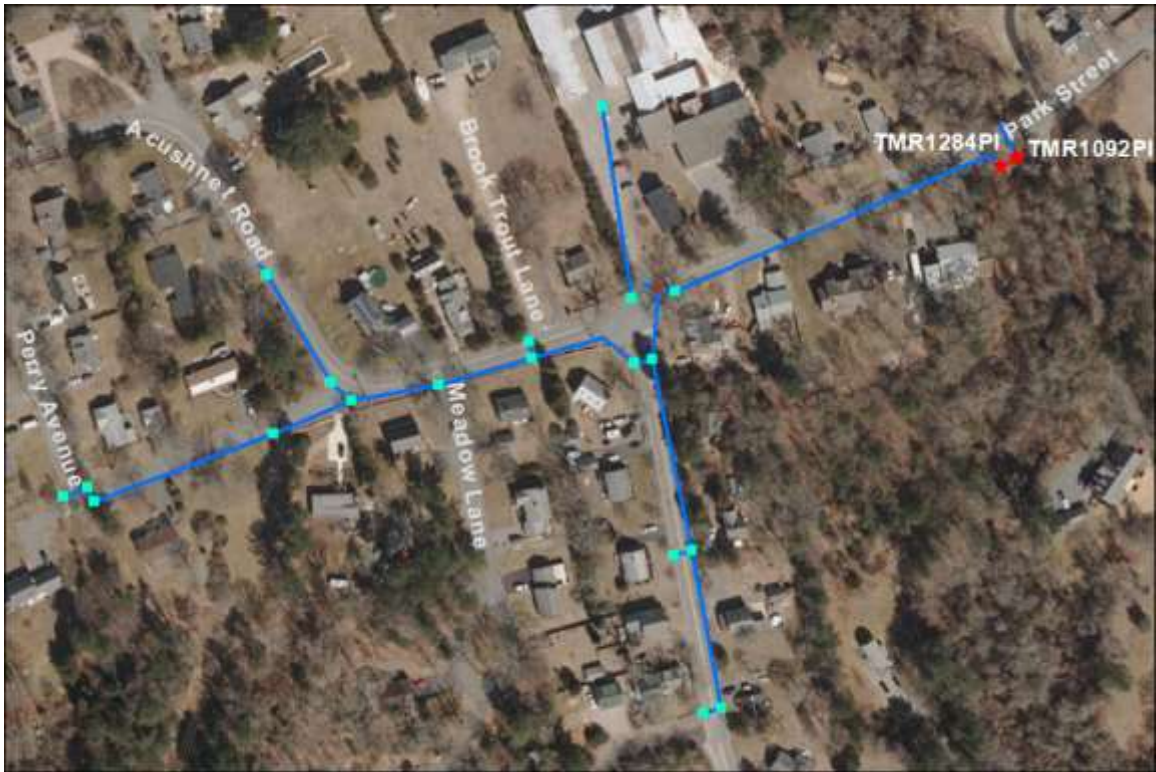
TMR1092PI (culvert) and TMR1284PI (outfall) – Park Street: no issues found; the boat yard appears to drain into this system; several dead-end pipes observed that are perhaps installed for future drain expansion.

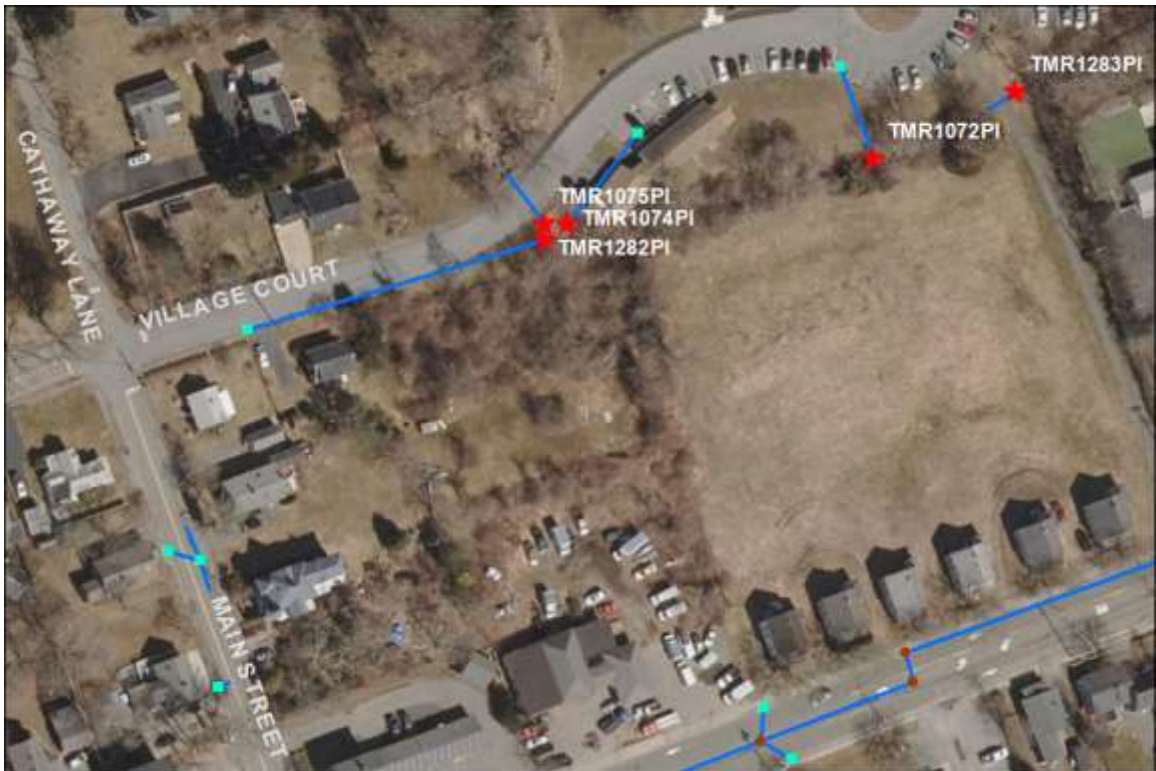
Housing Authority at Village Court: no issues found; TMR1075PI and TMR1283PI are simple culverts; TMR1074PI and TMR1072PI drain one catchbasin each; TMR1282PI could not be found; Main Street may connect to Route 6.

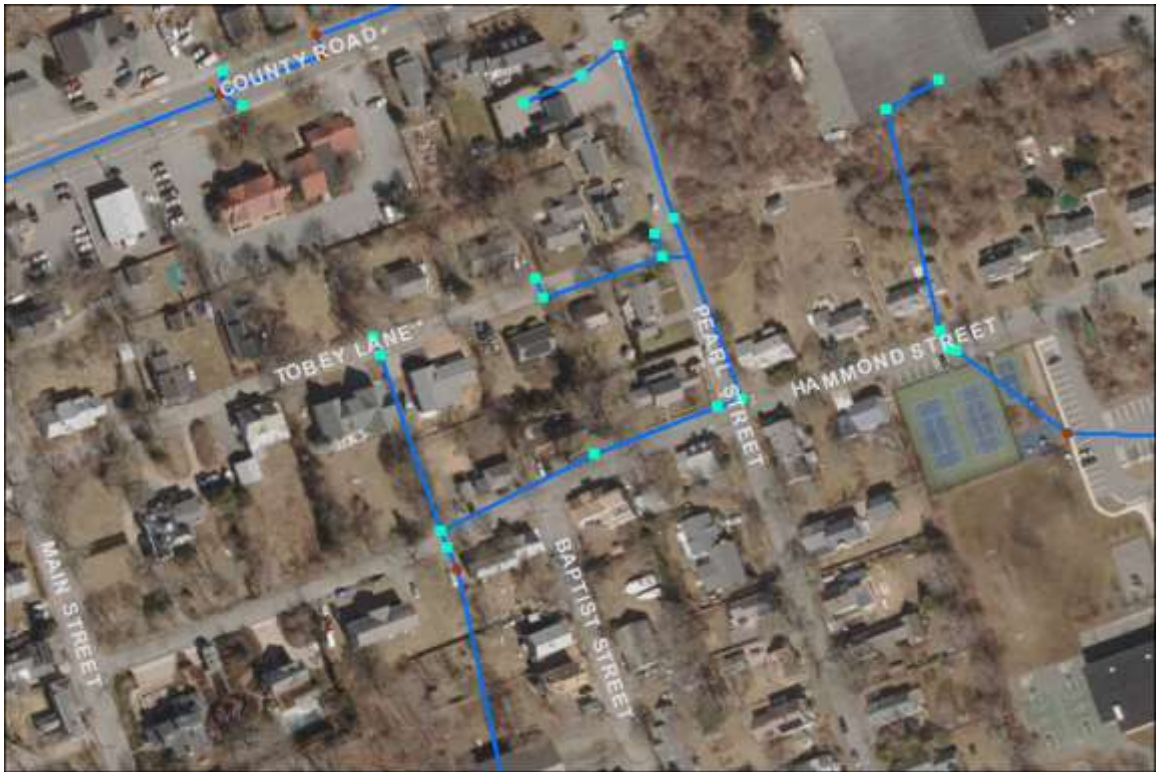
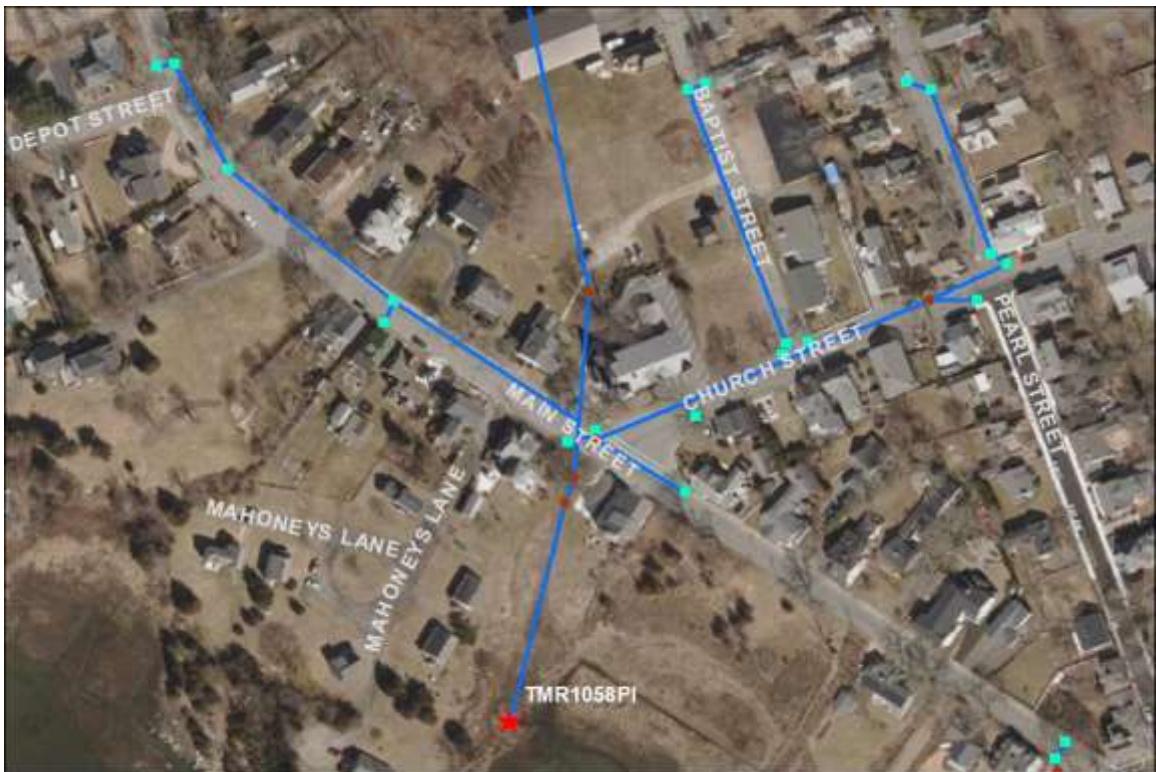
TMR1058PI – Main Street: no issues found; this is an extensive network and cumulates into a covered culvert with several pipes entering that cross Main Street; catchbasins on Church and Baptist Streets require cleaning.

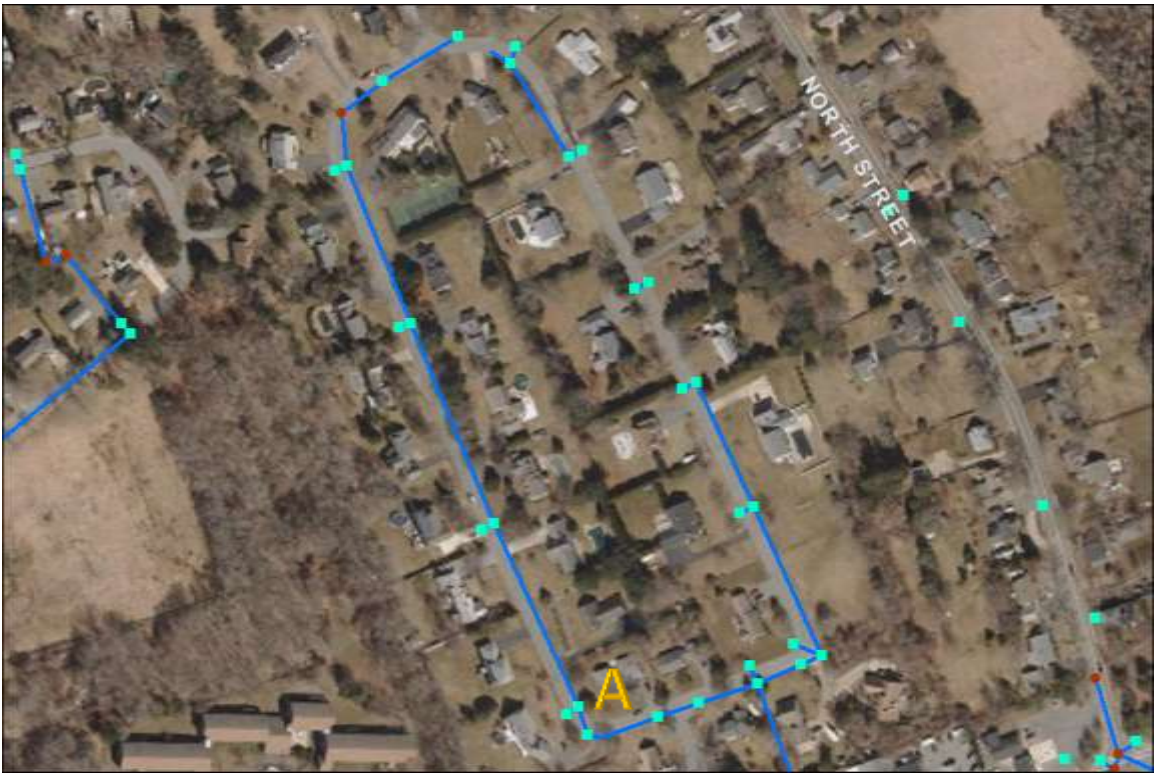
Upland Way and Hitching Post Road: no issues found; blocked pipes were reported and an attempt to jet the obstruction was made; the source of the problem is a poorly installed bend in the pipe at the location marked A; this storm drain network continues South across route 6 and then to the Bay; there may be a state interconnection at Route 6; this investigation stopped at Hitching Post Road.
