**The Buzzards Bay Stormwater Collaborative
Healthy Communities Grant Water Quality Data Report
6 May 2019 - Final**

Town of Mattapoisett

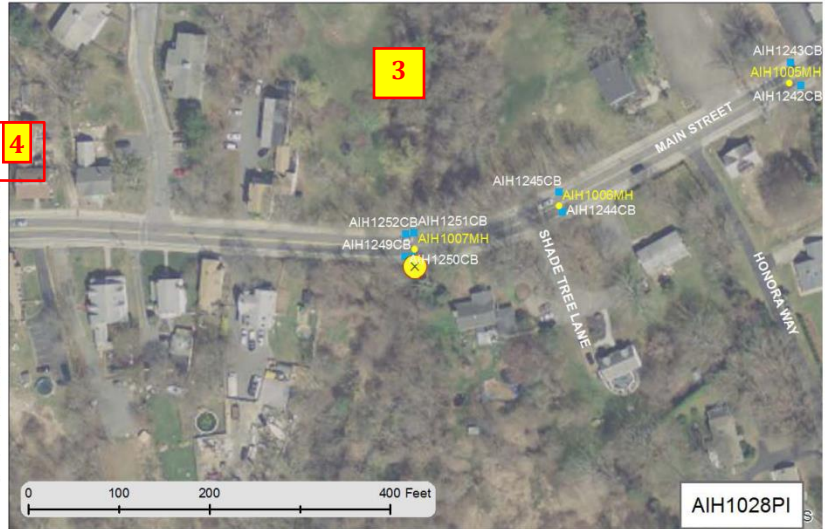
DW: Low to Moderate levels of Bact. (4 out of 6). DW Rank: Bact (1), Nitrates(1), Total 2. WW: Moderate Bact levels and elevated Amm, Nitrates, and Surf in WW. WW rank: Bact (1), Amm/Nitrates/Surf (1 ea), Total 4. Recommend: Continue to monitor both DW and WW. If DW, collect sample only if flow is evident, if stagnant (no flow), make a note on data sheet indicating no flow. Investigate for potential ID. Impair: None, discharge into trib of Acu R.

Rating
 Wet Weather: 4 **10**
 Dry Weather: 2
 2 'No Sample Visits' **11**

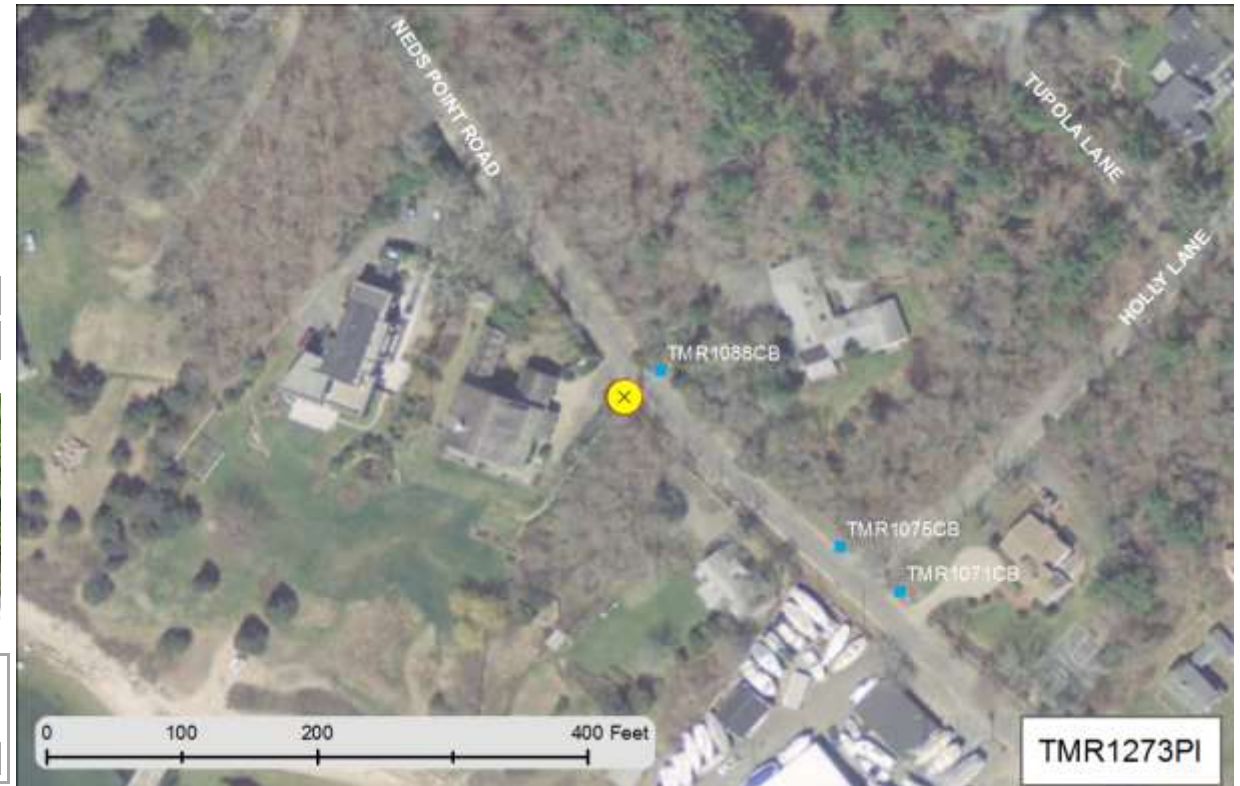
Although there were 2 no flow events, there were also 3 samples with water flowing during dry events, one of which had moderate levels of bact. DW rank: Bact (1), Surf (1), Total 2. WW Rank (1 sample): Bact (1), Nitrates/Surf (1 ea), Total 3.
Recommend: Continue monitoring for DW and WW. Matt Har Impair: Bact and N

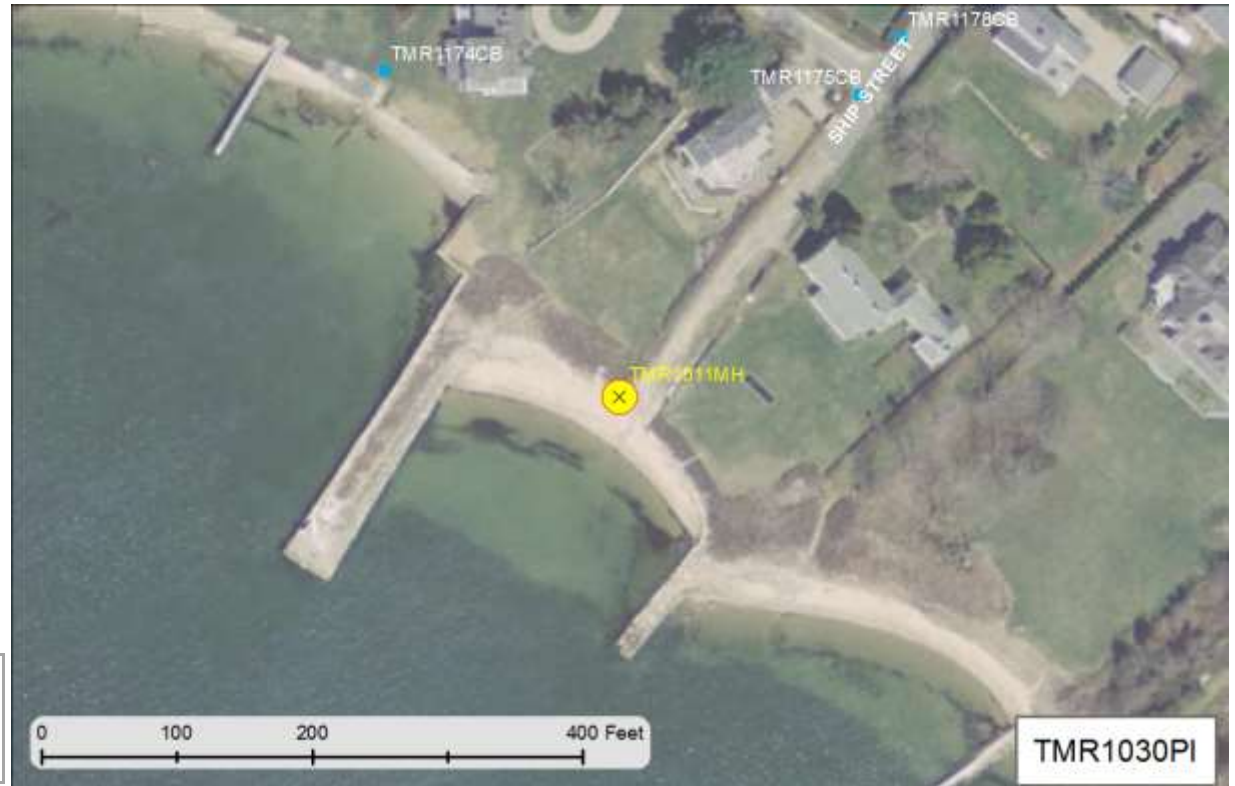
DW: No flow, no issues. Recommend:
Collect WW samples for evaluation
(none collected). Matt Har Impair:
Bact and N

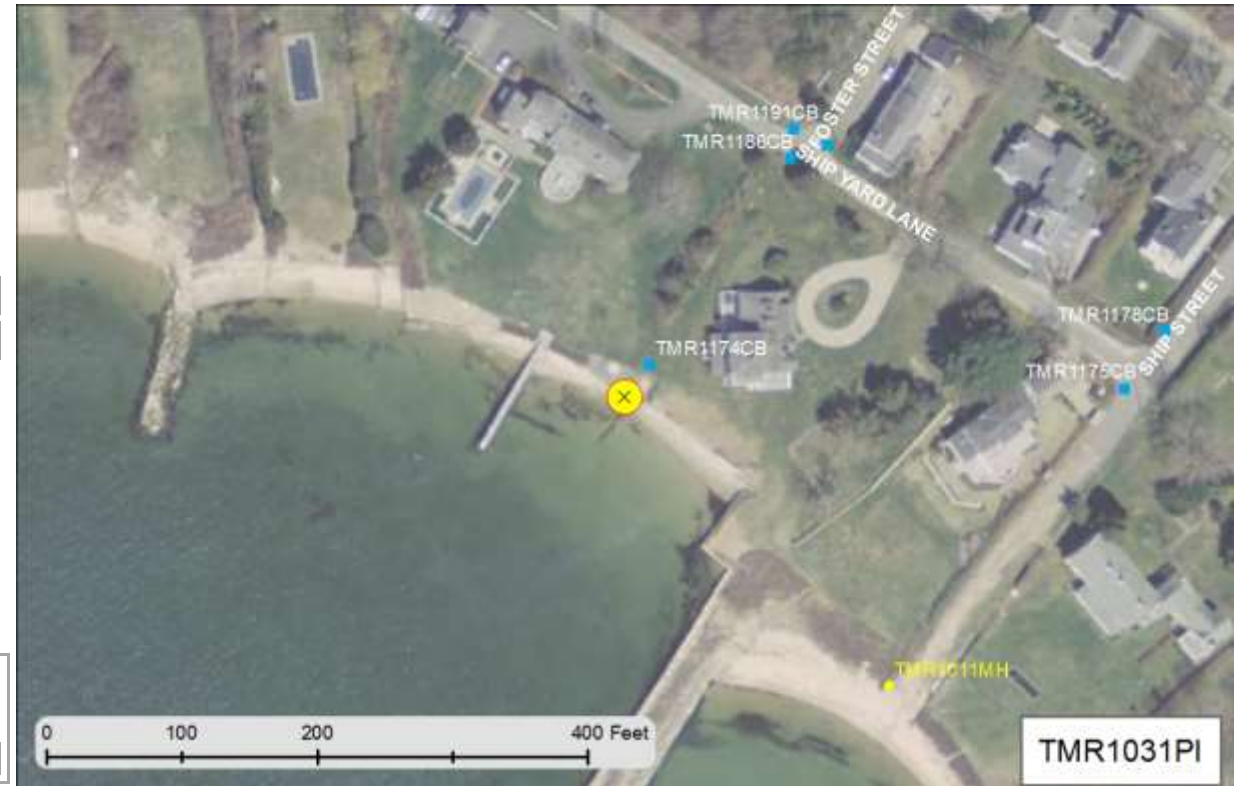
1CB with 2 DP (TMR1031PI) and (TMR1274PI). Probably TMR1031PI replaced TMR1274PI. DW rank: Bact (1), Amm, Nitrates, Surf (1 ea), Total 4. WW Rank (1 sample) Bact (2), Amm/Nitrates/Surf (1 ea), Tot. 5. Recommend: Continue DW and WW monitoring. If collecting a DW sample in sump, make note in data sheet if the sump is flowing (not stagnant). Investigate stormdrain for potential ID . Matt Har Impair: Bact and N

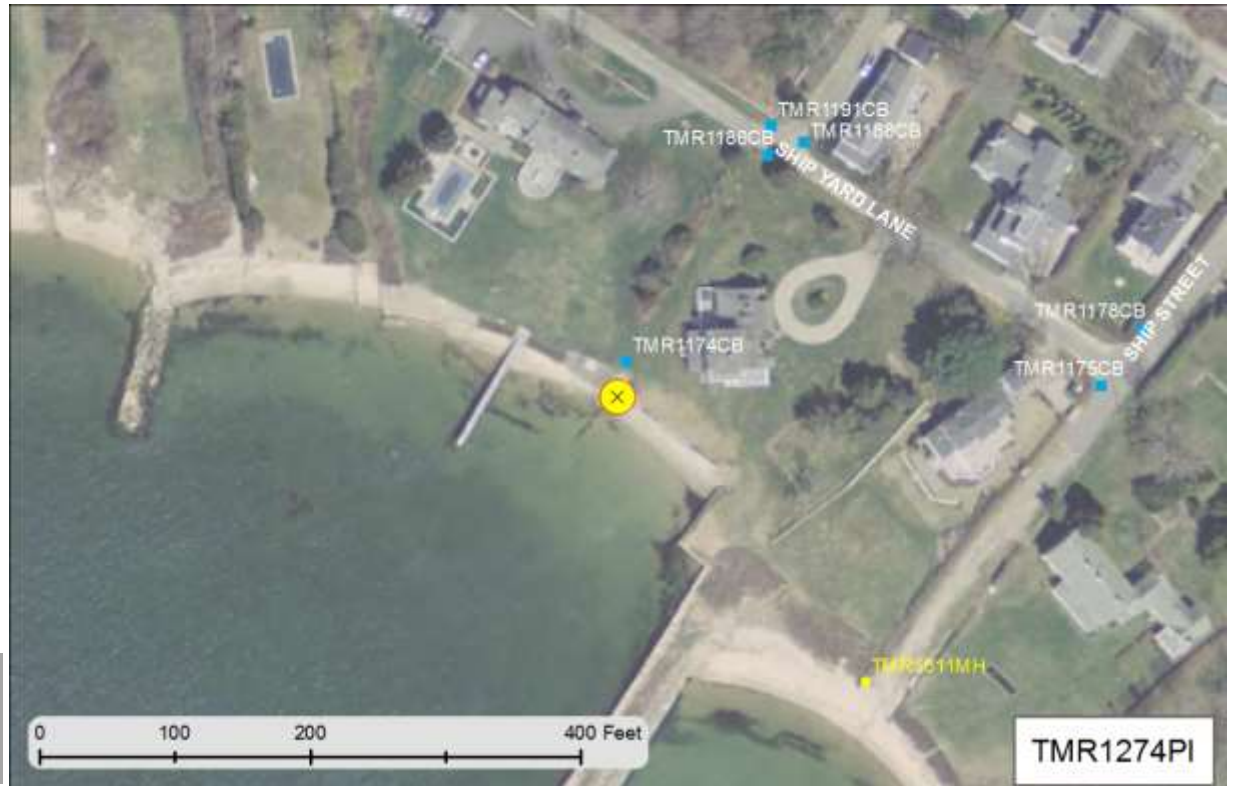
There are two pipes in close proximity (TMR1031PI). Check TMR1174CB as this may not be a functioning pipe, replaced by TMR1031PI? Follow recommendations for TMR1031PI - Recommend: Continue DW and WW monitoring. If collecting a DW sample in sump, make note in data sheet if the sump is flowing (not stagnant). Investigate stormdrain for potential ID . Matt Har Impair: Bact and N.

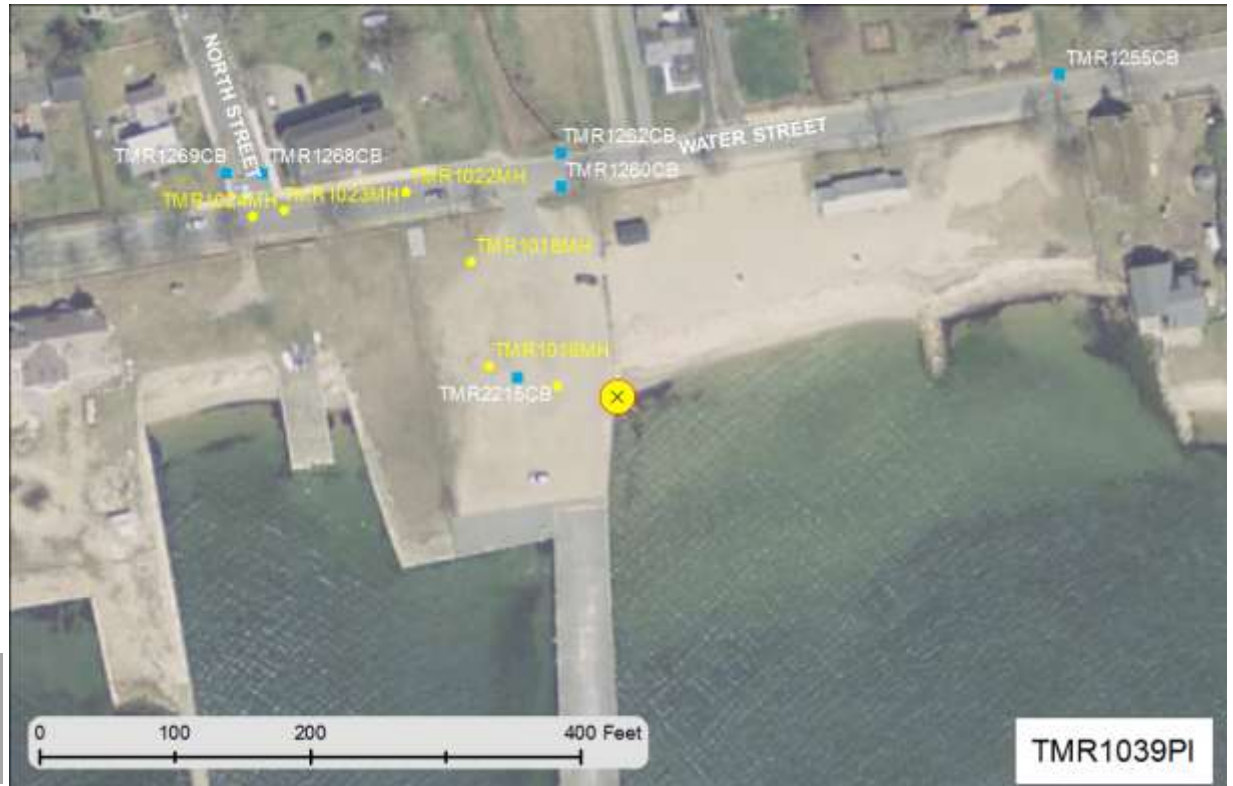
The drainage on this site is complicated, 2 drainage systems into 1 discharge, one system, stormwater from North and Water St flows through an infiltration treatment BMP. The other system drains some of Water Street, plus the drainage ditch north of Water Street. DW: All pipe samples indicate a moderate Bact count. DW Rank: Bact (1) Nitrates/Surf (1 ea), Tot. 3. WW: 1 Sample at pipe high for Bact. WW Rank: Bact (2), Nitrates/Surf (1 ea), Tot. 4. Recommend: Continue to monitor for Bact.

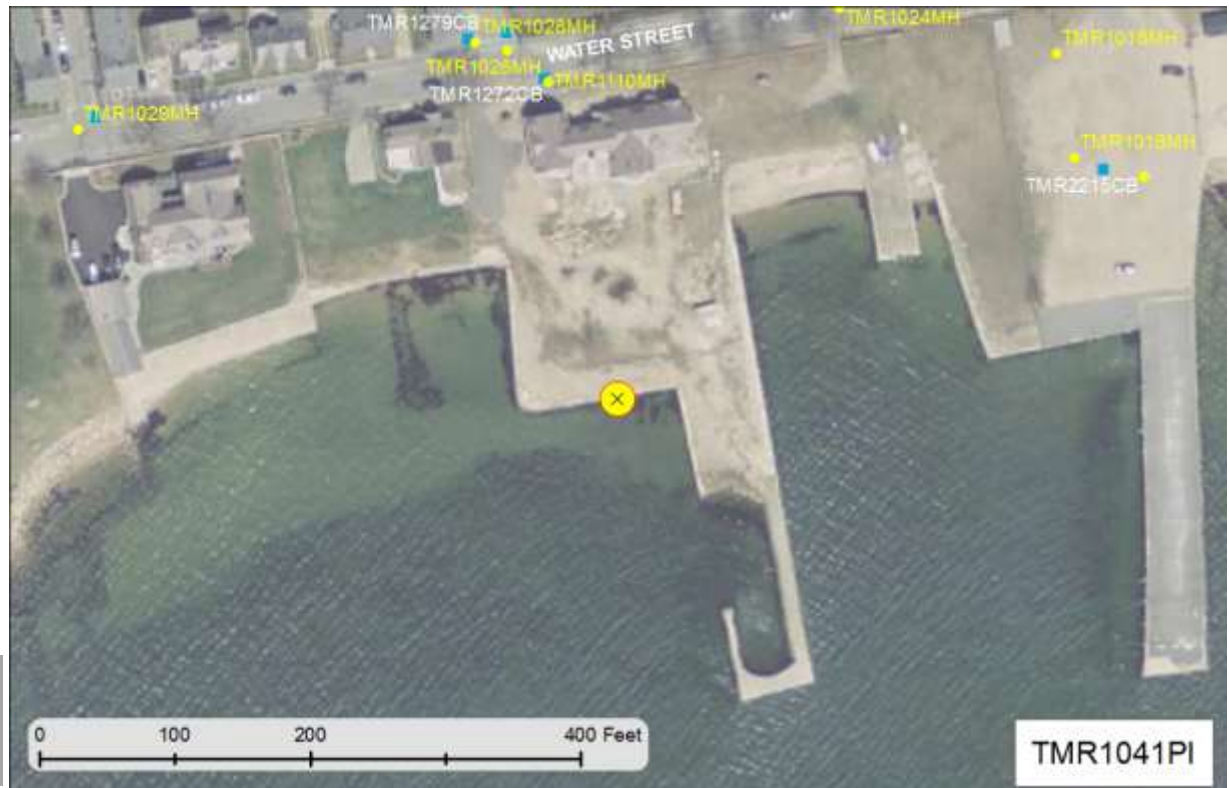
DW: Low to moderate Bact counts,
DW Rank: Bact (1), Nitrates (1), Tot. 2.
WW: High Bact counts, WW Rank:
Bact (2), Nitrates (1), Tot. 3.
Recommend: Continue WW
monitoring. Matt Har Impair: Bact and
N

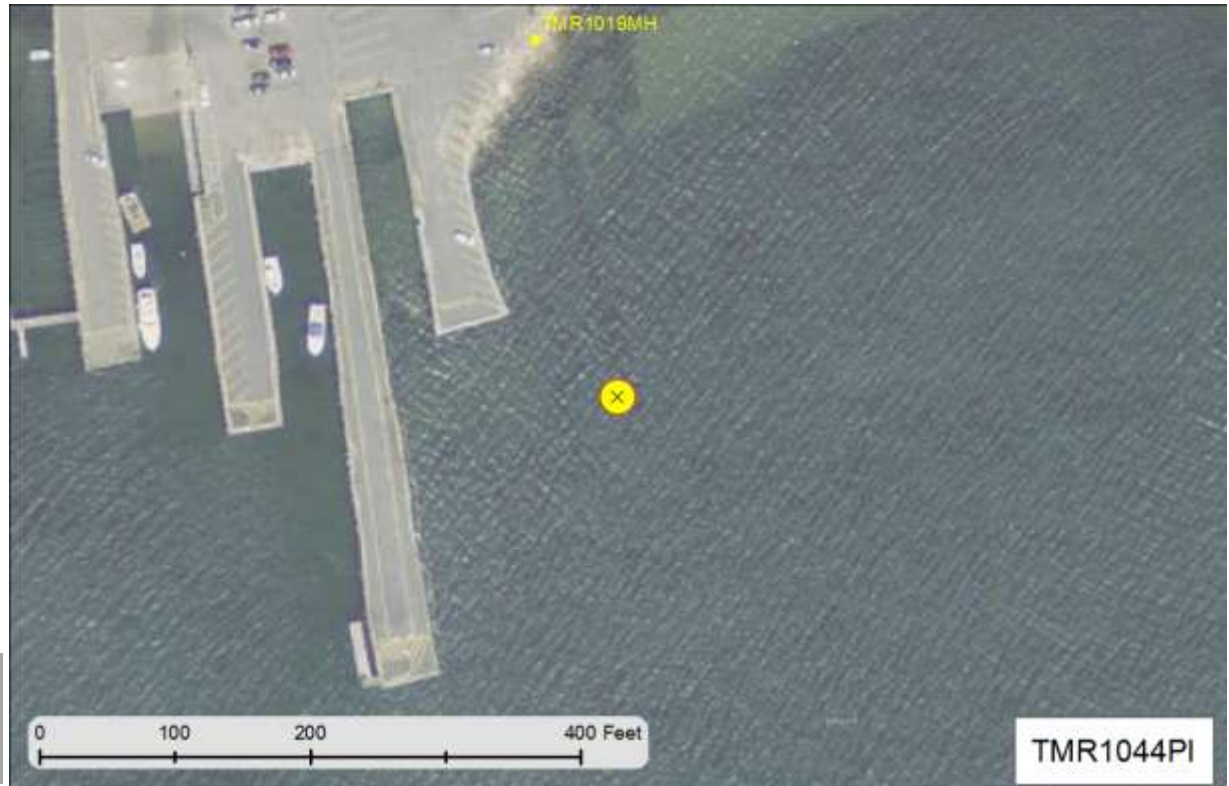
DW rank (3 pipe samples): Bact (1) and Nitrates/Surf (1 ea), Total 3. WW Rank (1 Sample) Nitrates/Surf (1 ea), Total 3. Recommend: continue to monitor DW and WW. Matt Har Impair: Bact and N

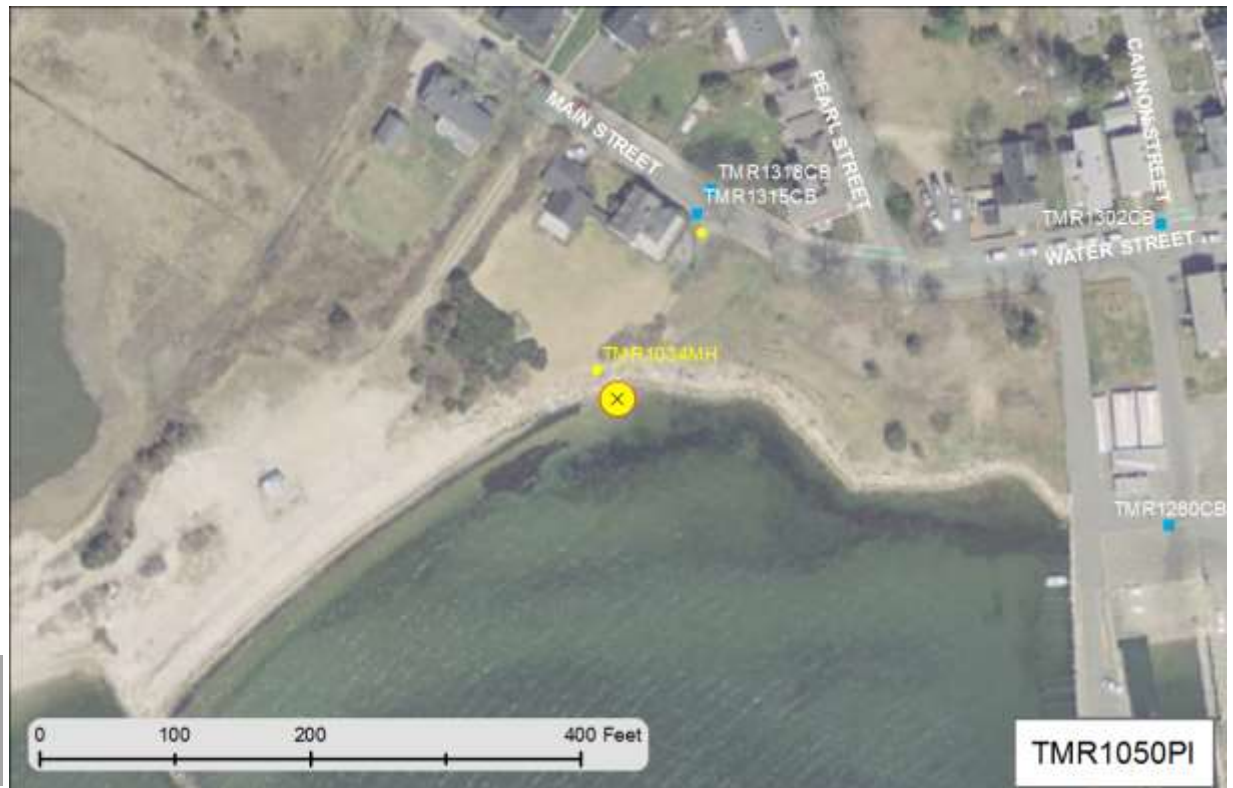
DW no flow, no issues. Recommend:
Collect WW samples for evaluation
(no samples taken). Matt Har Impair:
Bact and N

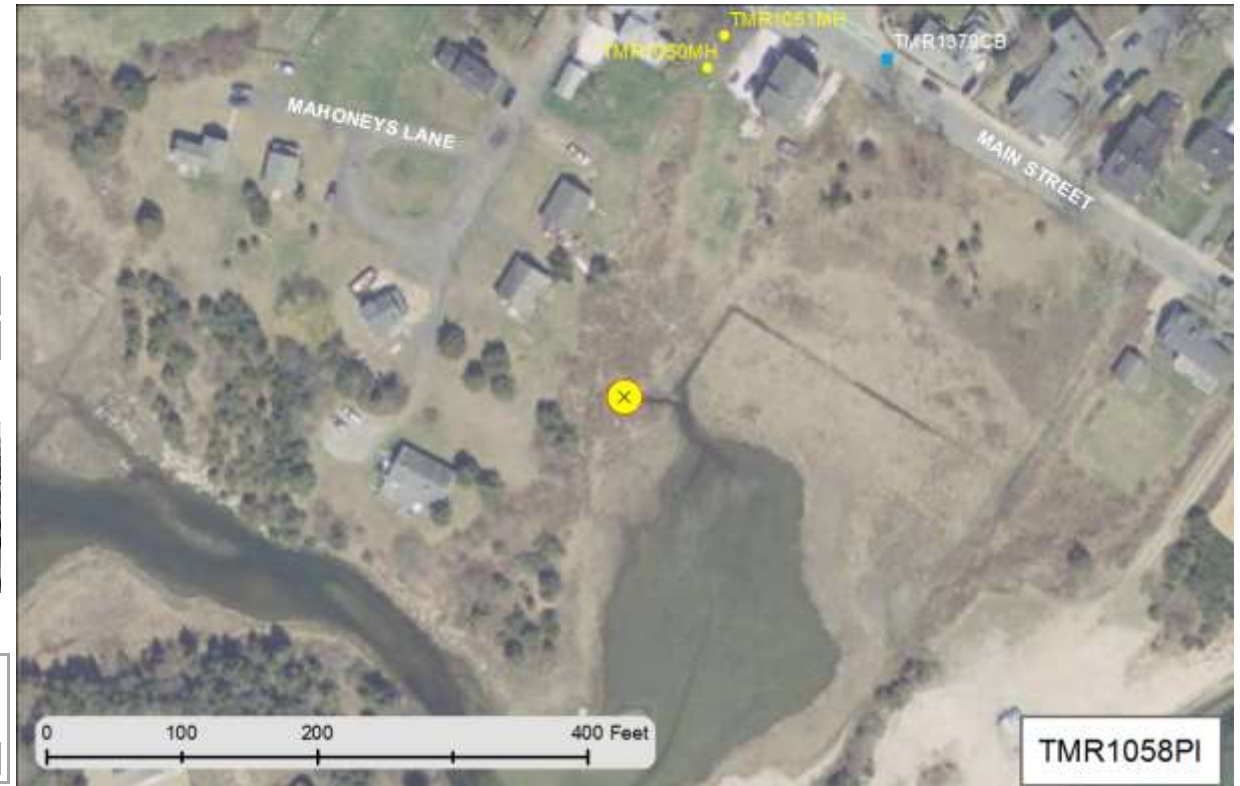
DW, No flow, no issues. WW (1 sample) Rank: Bact (2), Nitrates/Surf (1 ea) Total 4. Investigate for potential ID. Recommend: Continue to monitor during WW. Matt Har Impair: Bact and N

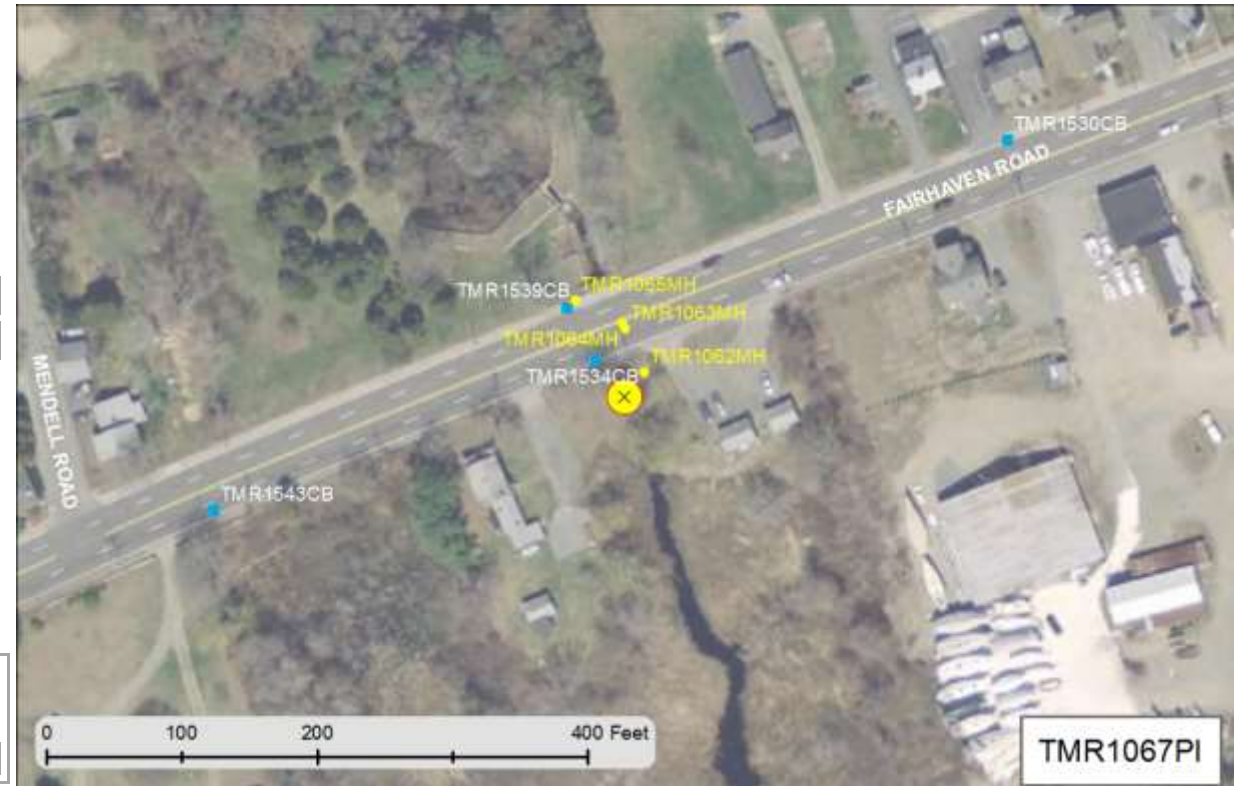
DW: Although there were 3 DW, no flows, there was 1 DW sample that had some flow with moderate levels of bact. DW rank Bact (1) Nitrates/Surf (1 ea), Total 3. WW Rank (1 sample): Bact (2), Nitrates/Surf (1 ea), Total 4. Recommend: Continue monitoring DW and WW. DW only monitoring when flow is evident (not stagnant). If not flowing make a note on data sheets. In conjunction with monitoring TMR1067PI, monitor TMR1068PI and TMR1070PI

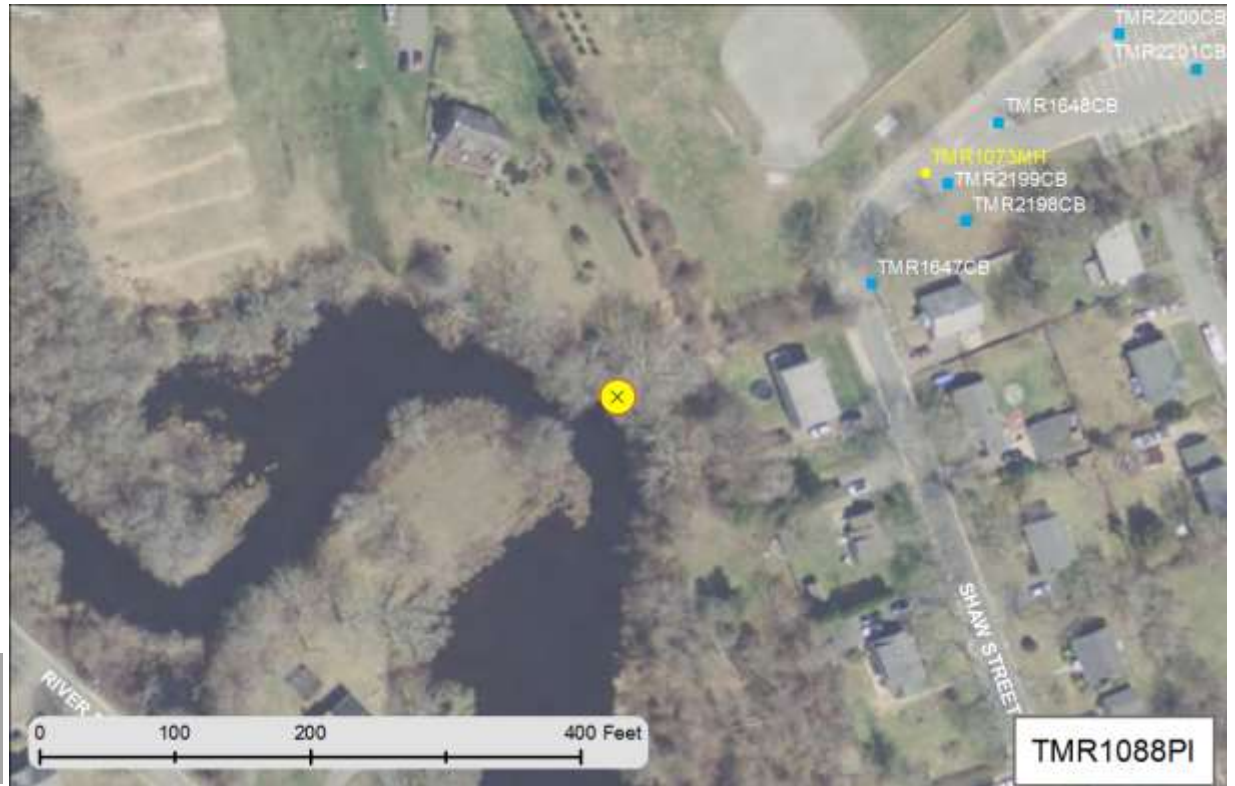
DW no flow, no issues. WW (2 pipe samples) Rank: Bact (1), Amm/Nitrates (1 ea), Total 3.
Recommend: Continue monitoring in WW to confirm presence of ID and consider potential BMP for bact. Matt R Impair: Bact

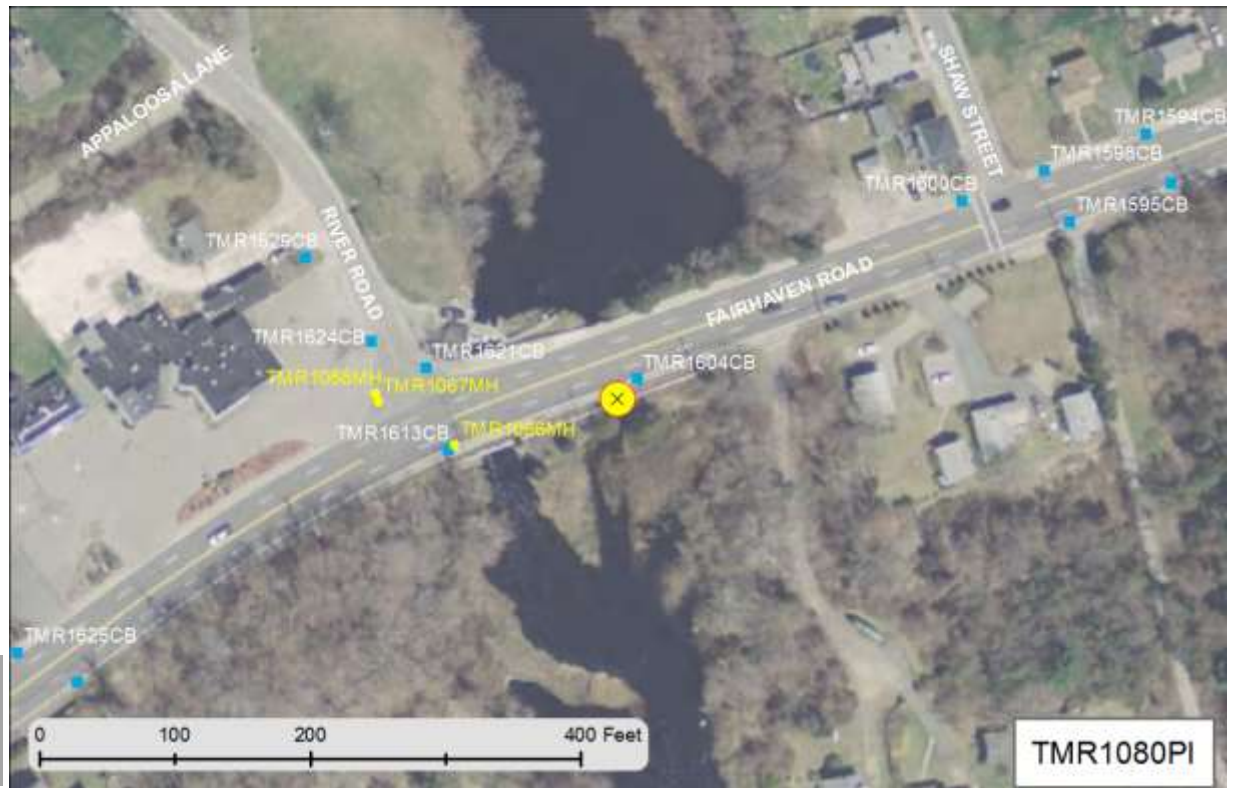
DW no flow, no issues. WW (2 samples) Rank: Bact (2), Amm/Nitrates/Surf (1 ea), Total 5. Recommend: Continue monitoring for WW. Begin investigating for sources of bacteria and potential ID especially from town drainage. Monitor consecutively with TMR1082PI. Notify Mass DOT of monitoring and investigative results. Matt R Impair: Bact

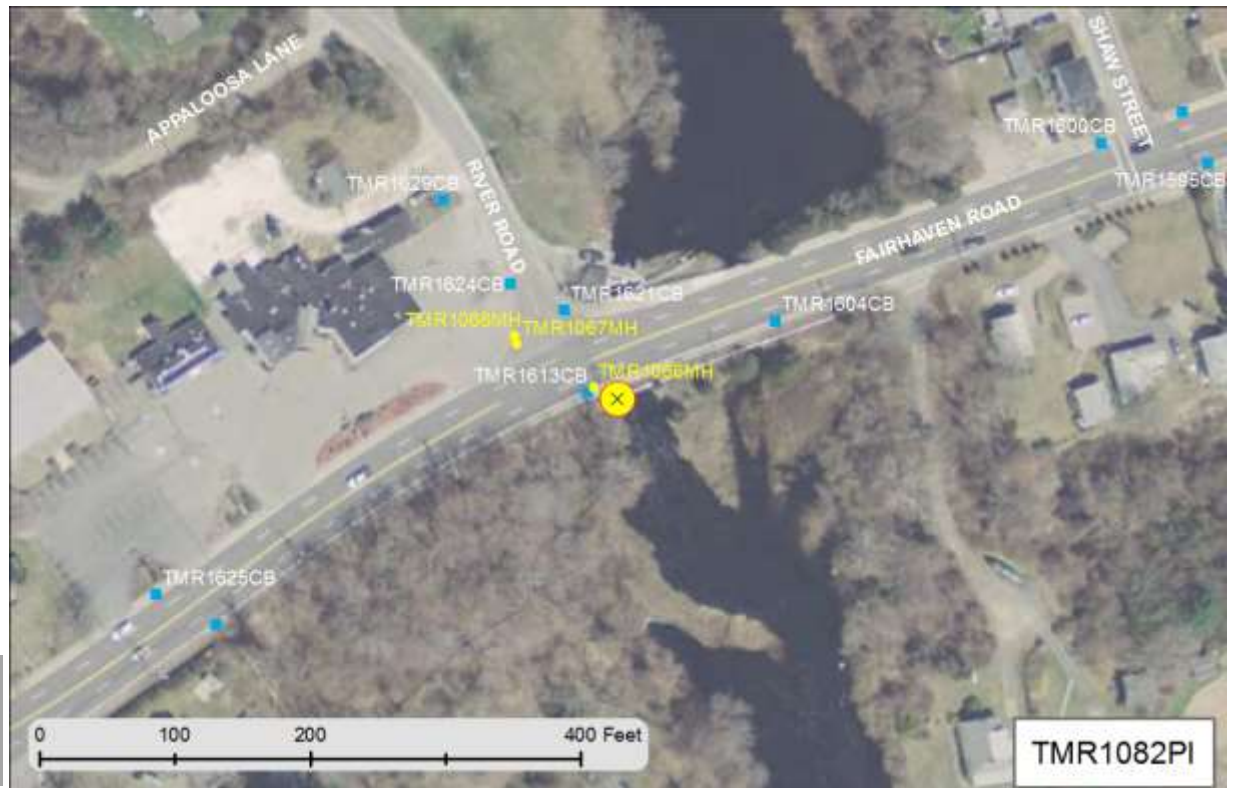
| FacilityID | SampleDate | SampleID | SampleType | Water Classification | Last Rain | 12hr Rain | pH | Temp | Salinity | Ammo | Nitrate | Surfact | Enteroc. | Fecal C. |
|---|---|---|---|---|---|---|---|---|---|---|---|---|---|---|
| TMR1082PI | 7/29/2016 | 6MT29JUL10-A | pipe | Fresh Water | 0 hrs | 0.23 in | 7.11 | 25.6 | 0.03 | 0.50 | 1.76 | =0.3 | 2500 | 4800 |

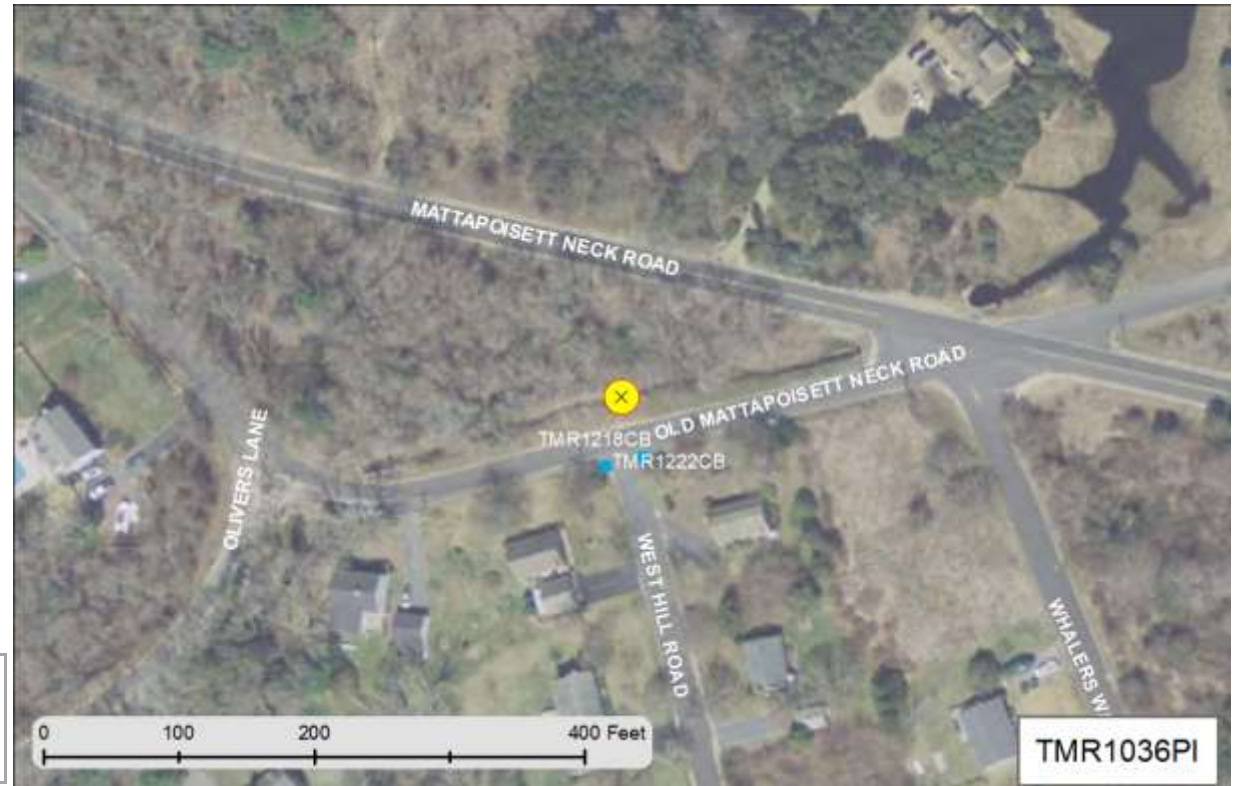
DW: Although there are 2 no flow DW observations, there are some dry weather discharges indicating potential ID. DW Rank: Bact (1), Nitrates, Surf (1 ea), Tot. 4. WW: (2 samples with moderate to high Bact. Also one stream sample near the pipe with also high levels of Bact. WW Rank Bact (2), Amm, Nitrates, Surf (1 ea) Total 5. Recommend: Investigate for potential ID. Continue DW and WW monitoring. Any DW sump sample indicate if sump is flowing (not stagnant). Matt Har Impair: Bact and N

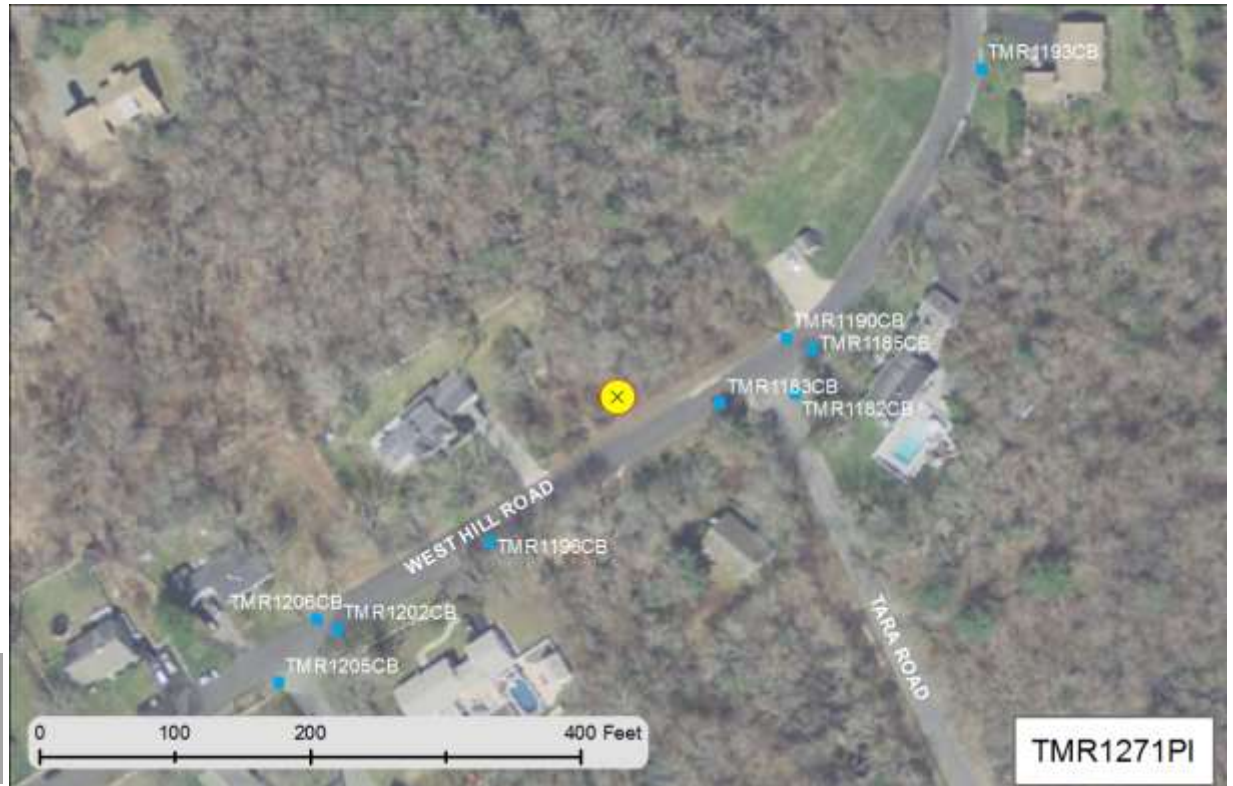
| FacilityID | SampleDate | SampleID | SampleType | Water Classification | Last Rain | 12hr Rain | pH | Temp | Salinity | Ammo | Nitrate | Surfact | Enteroc. | Fecal C. |
|---|---|---|---|---|---|---|---|---|---|---|---|---|---|---|
| TMR1183CB | 6/20/2016 | 6MT20JUN04-S | sump | Fresh Water | 208 hrs | 0 in | 6.29 | 27.9 | 0.16 | 0.25 | 0.00 | | 820 | 100 |

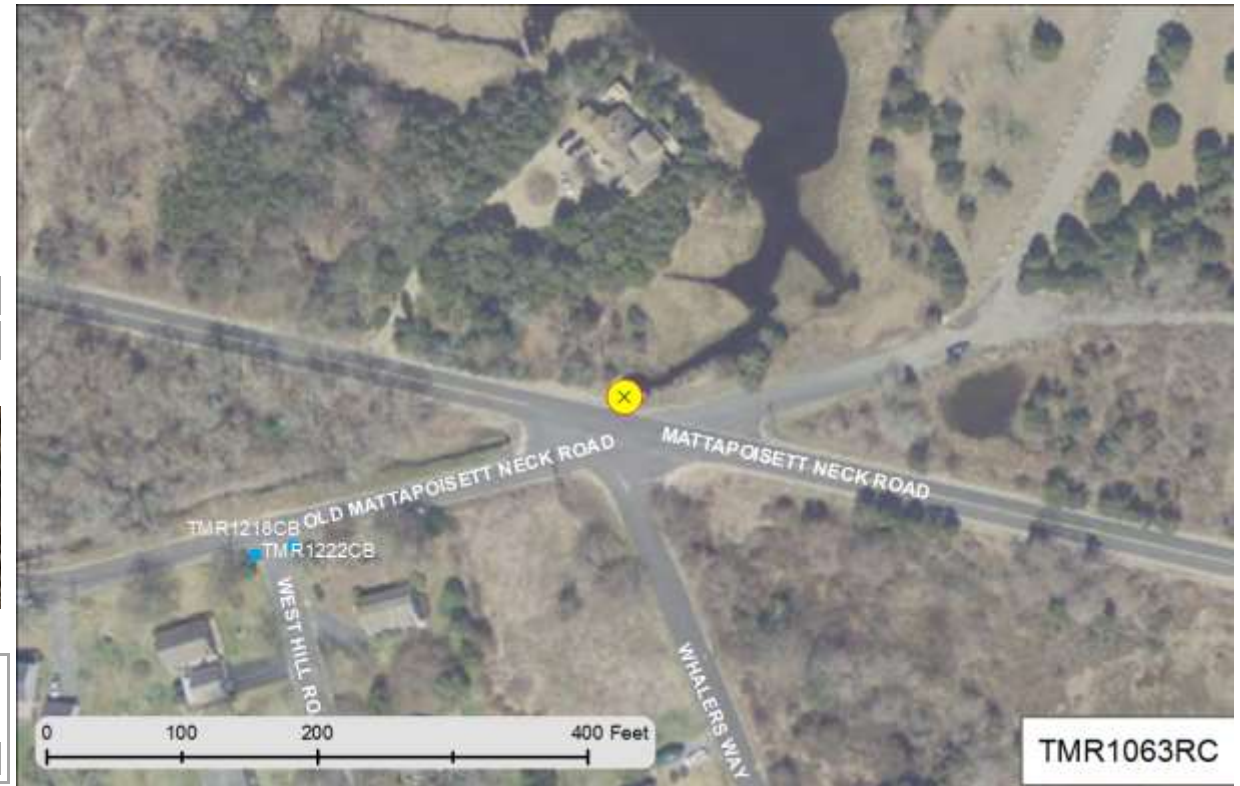
DW: no flow, no issues (RC). WW (1 sample) Bact (1), Nitrates/Surfactants (1 ea), Total 3. Recommend: Continue monitoring WW. Make note of contributing watershed flows as this may be a potential ID. Matt R Impair: Bact

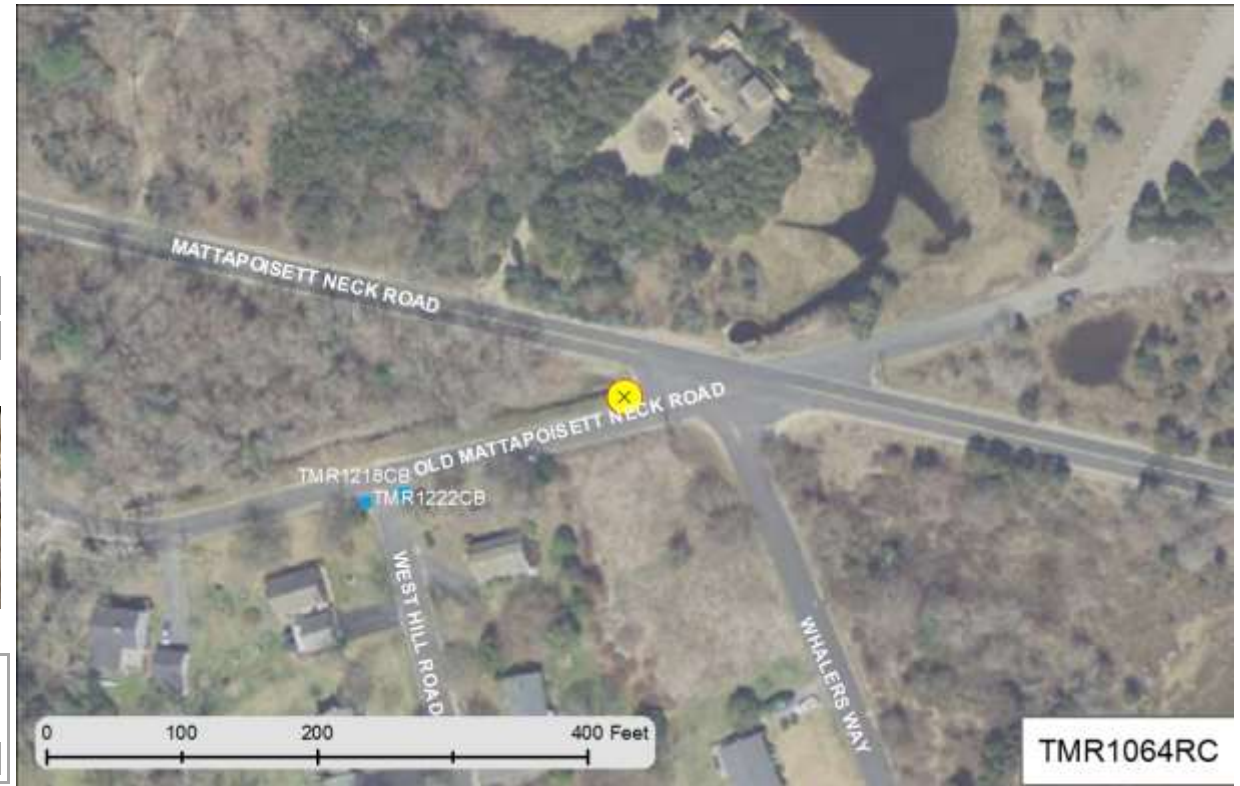
DW: no flow, no issues (RC). WW (1 sample) Bact (1), Nitrates/Surfactants (1 ea), Total 3. Recommend: Continue monitoring WW. Make note of contributing watershed flows as this may be a potential ID. Matt R Impair: Bact

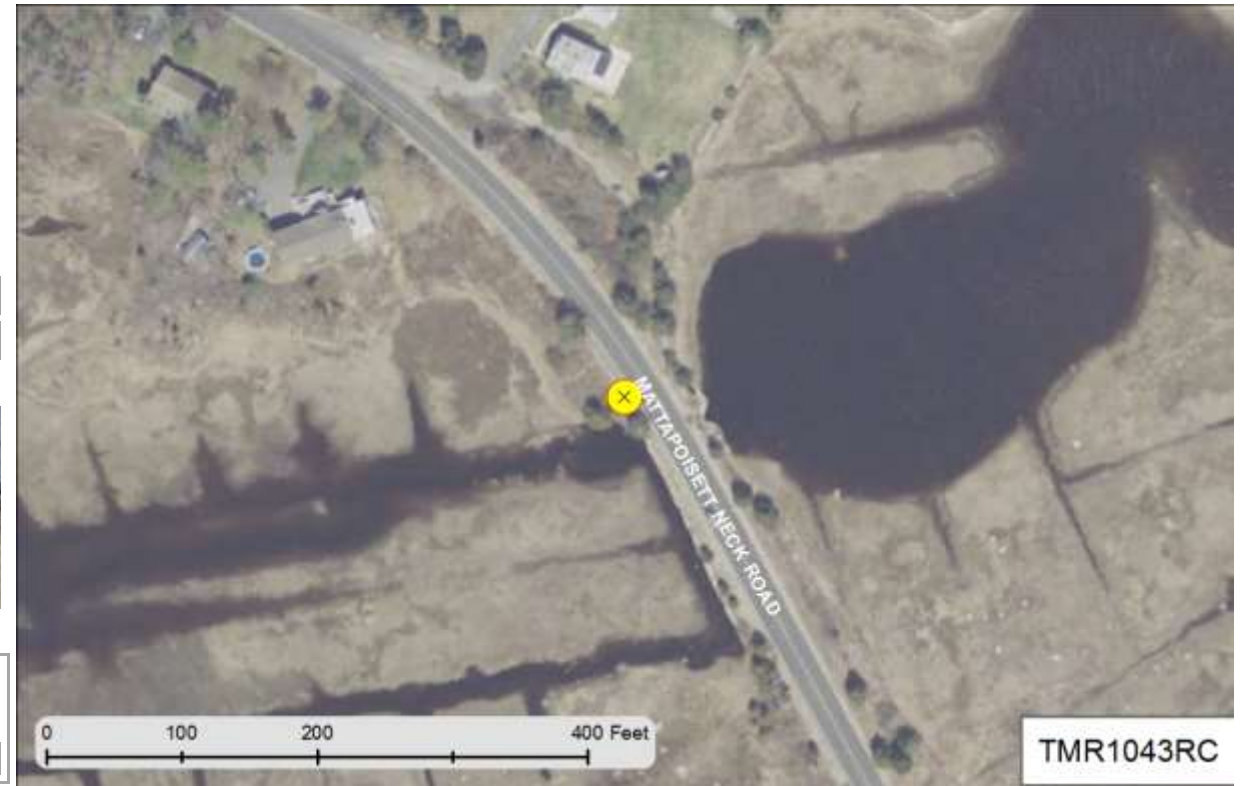
WW Rank (1 sample) Bact (1),
Nitrates/Surf (1 ea). Tot. 3.
Recommend: Investigate drainage
area including surface flows onto
Matt Neck Rd. Continue monitoring
WW. Matt Har Impair: Bact and N

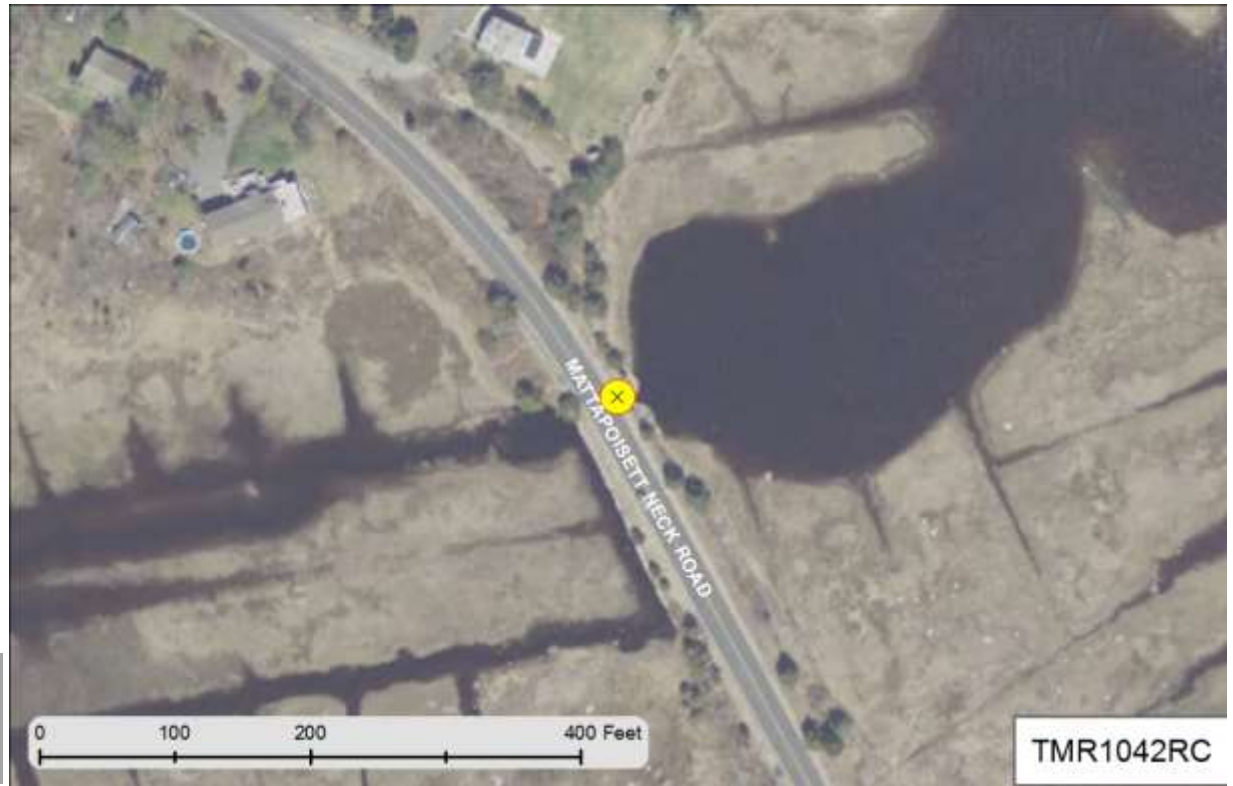
1 DW sample, No WW, Recommend:
Continue to monitor DW and WW .
Matt Har Impair: Bact and N

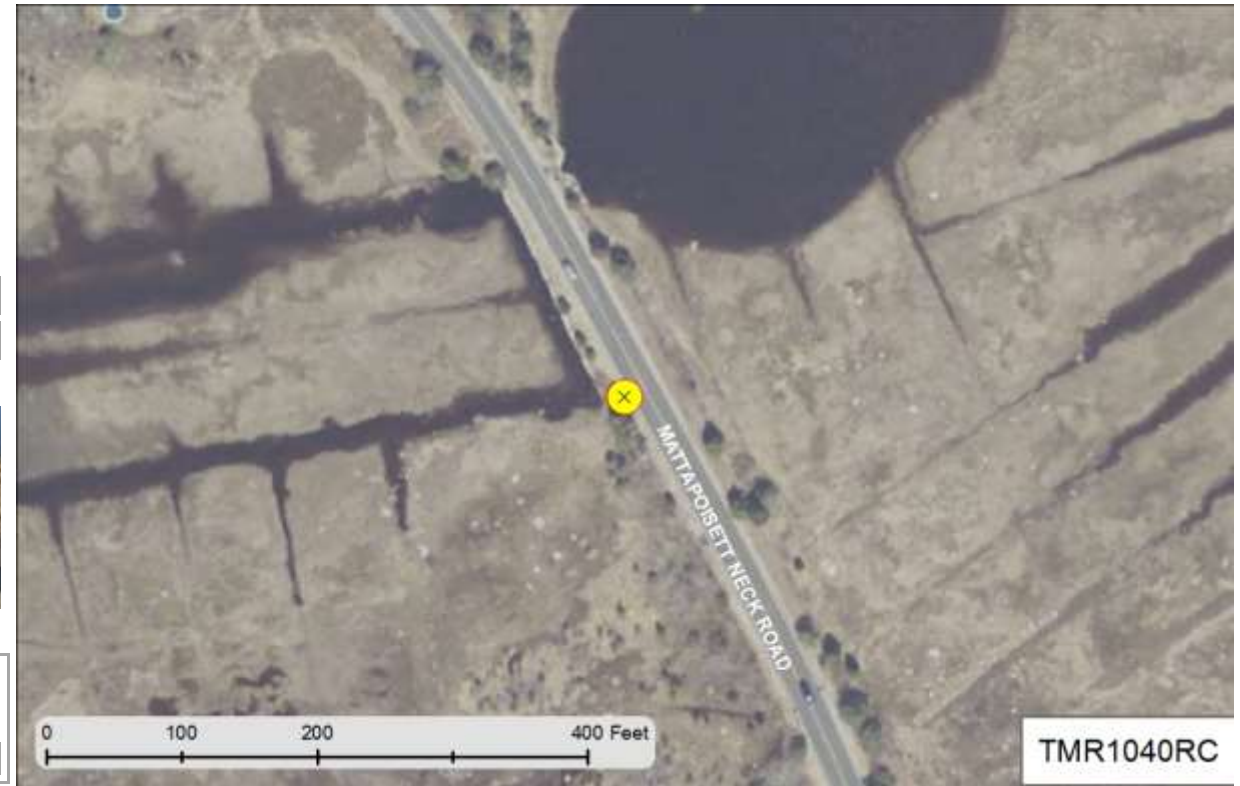
No Samples. Recommend: Collect WW samples for evaluation. Matt Har Impair: Bact and N

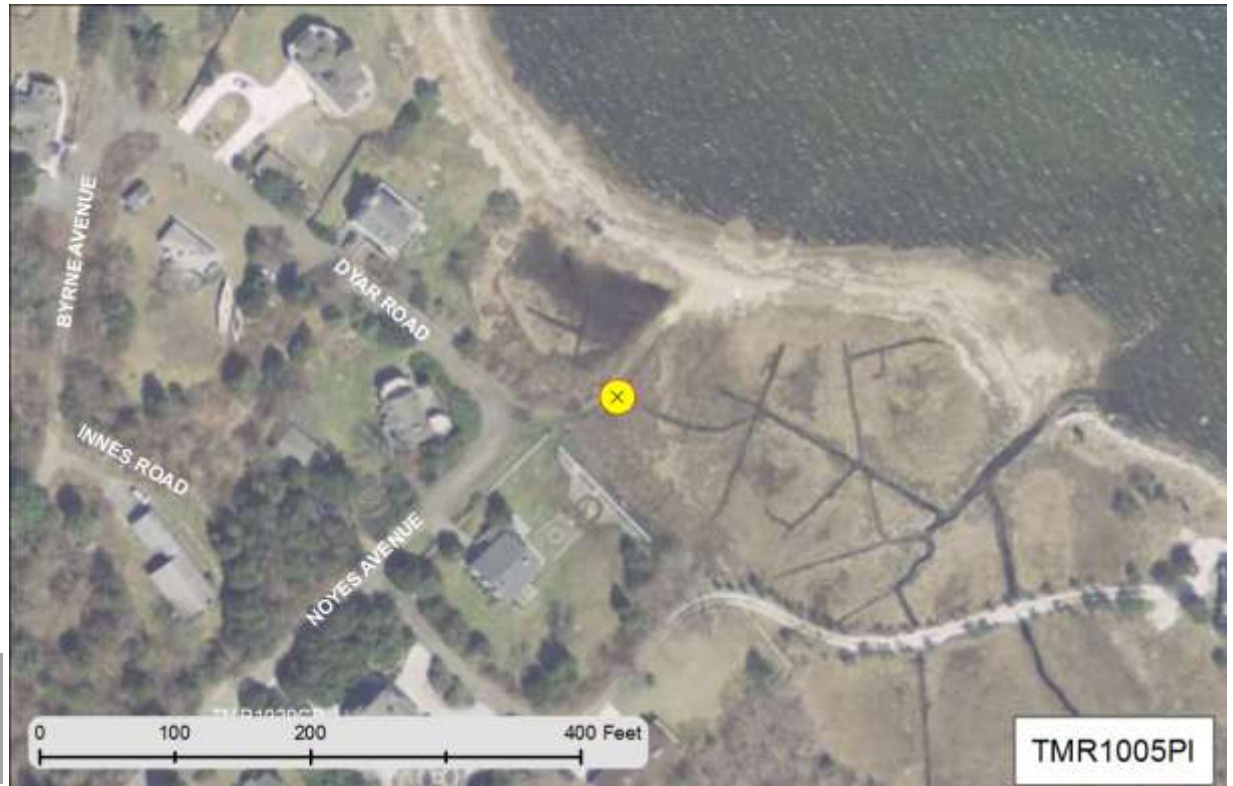
DW no flow, no issues. WW: only 1 sample, Rank: Bact (2), Nitrate (1), Total 3. WW Recommend: Continue monitoring for WW. Matt Har Impair: Bact and N.
