**The Buzzards Bay Stormwater Collaborative
Healthy Communities Grant Water Quality Data Report
6 May 2019 - Final**

Town of Mattapoisett

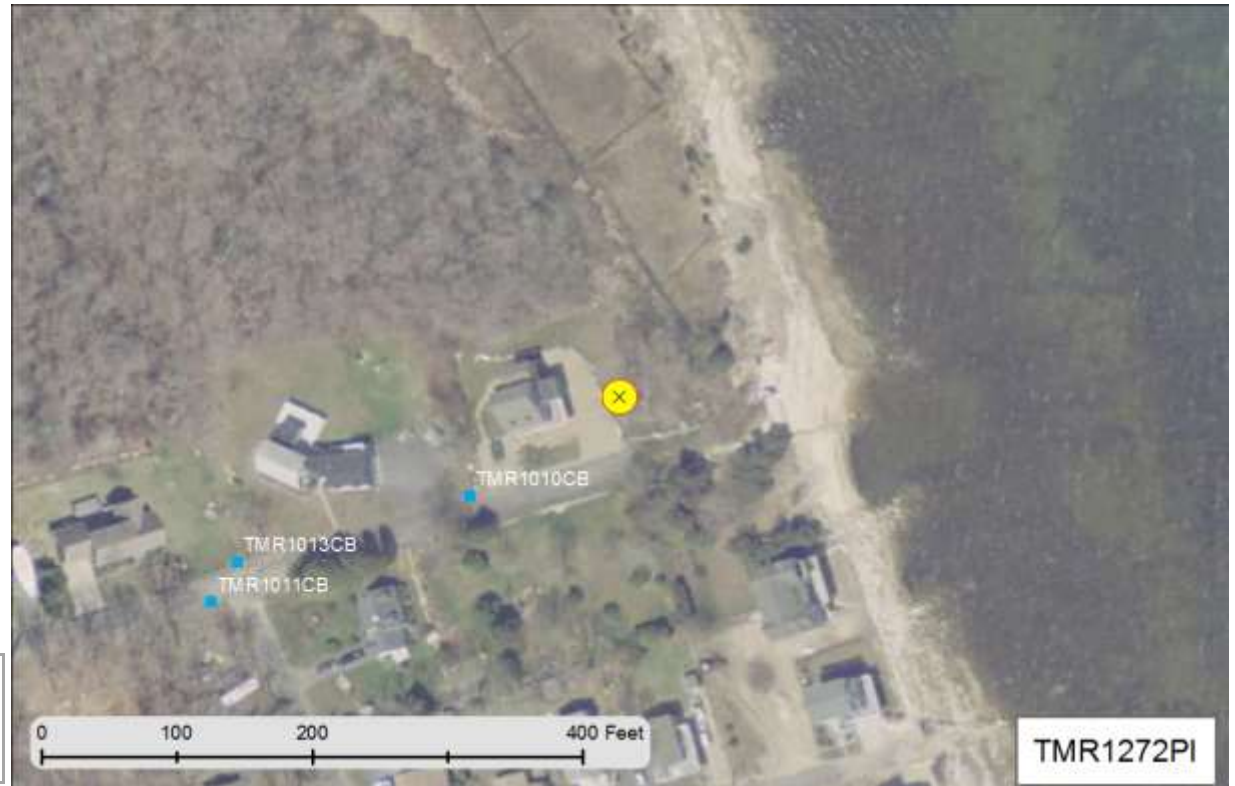
Although most of these samples were in the CBs sumps, the data indicates the presence of an ID and should be investigated. DW Bact ranged from moderate to high and surfactants over the testing capabilities. Comments in the data sheets referred to the water as gray in color. DW Rank: Bact (2), Amm/Surf (1 ea). Total 4. WW Rank: Bact (2), Amm/Nitrates/Surf (1 ea), Total 5. Recommend: Investigate for potential ID connection including any failed septic systems. Matt Har Impair: Bact

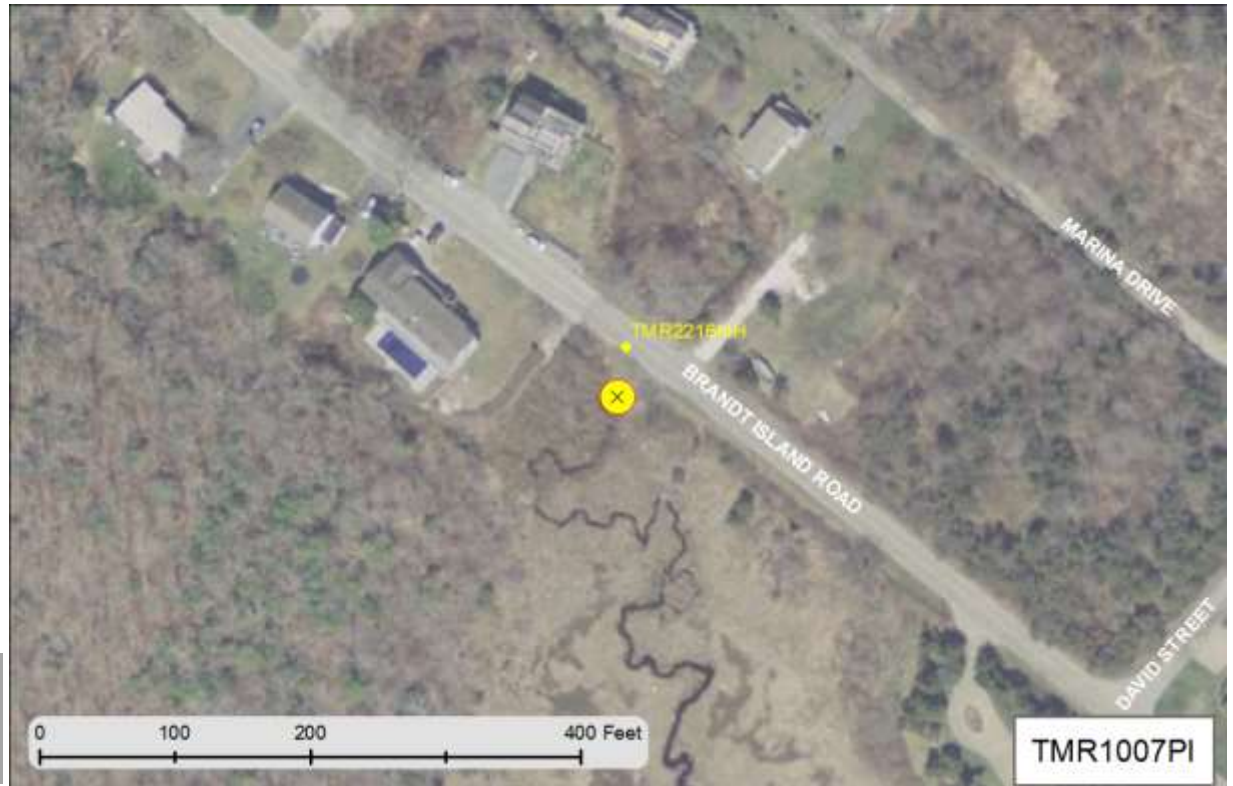
DW Rank: (1 sample) Bact (1), Nitrates (1), Tot 2, however remaining DW samples no issues. WW: higher level of concern due to elevated Bact after rain. WW rank: Bact (2) Nitrates (1), Tot 3, Area not sewered, possible septic system problems. Recommend: Determine drainage area of stormdrain pipe, does TMR1001MH connect into TMR2216MH or does TMR1001MH discharge into woods. If MHs connected, monitor both MHs and stream, If not connected, monitor TMR2216MH and stream. Invest for

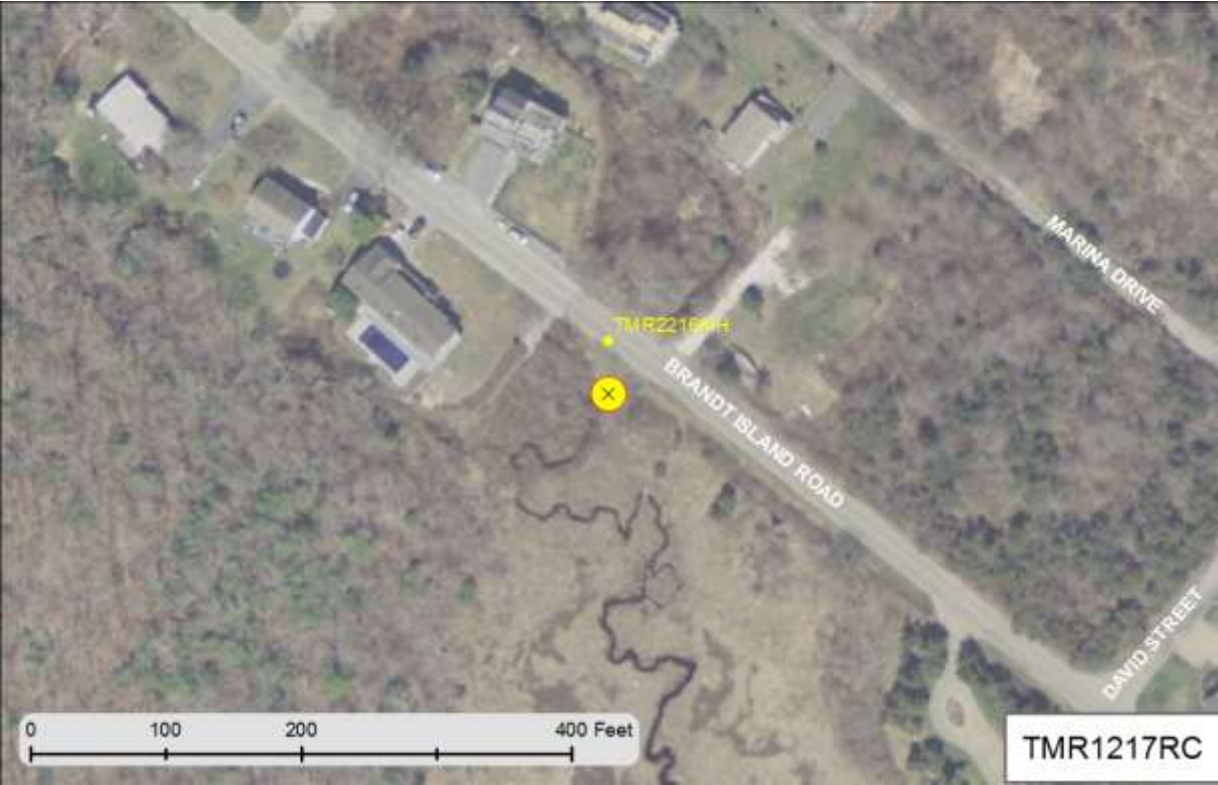
No samples for WW. Recommend:
Monitor WW. Nask B Impair: Bact

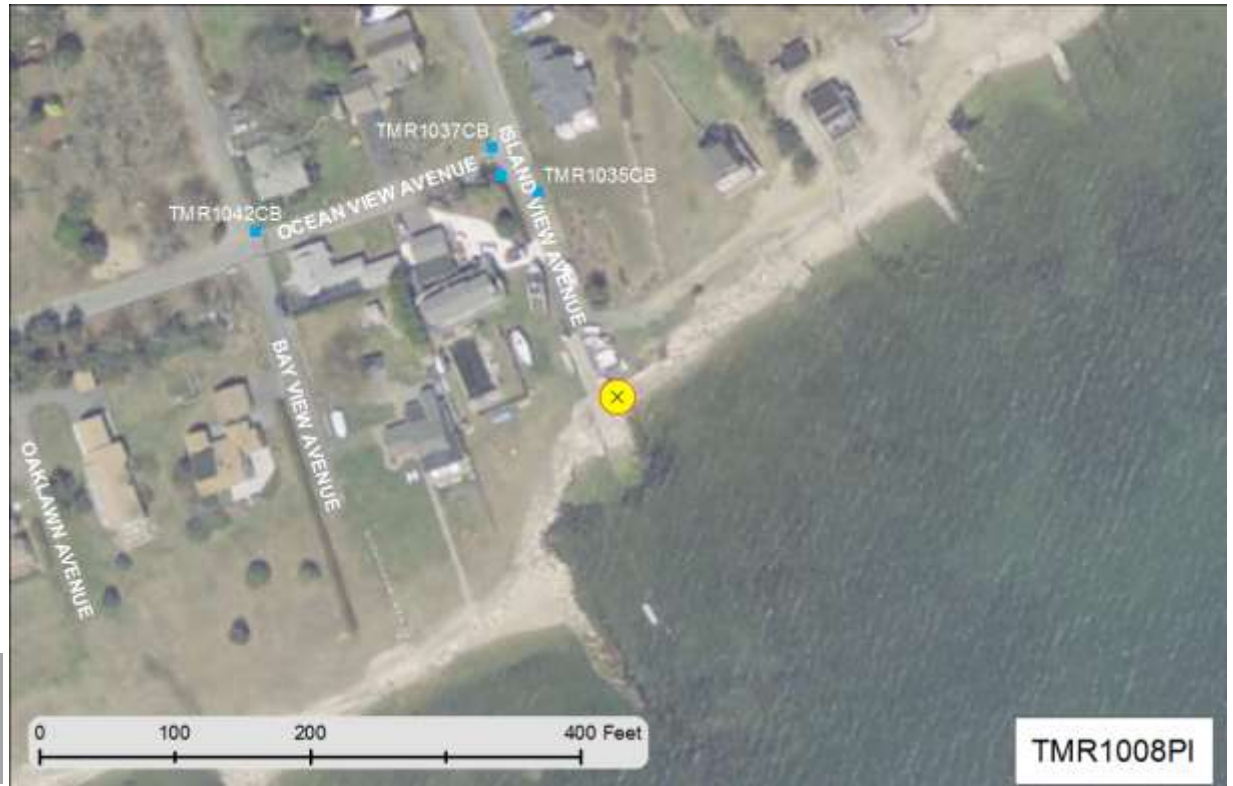
DW: No flow, no issues. Recommend:
Collect WW samples for evaluation
(none collected). NB Impair: Bact

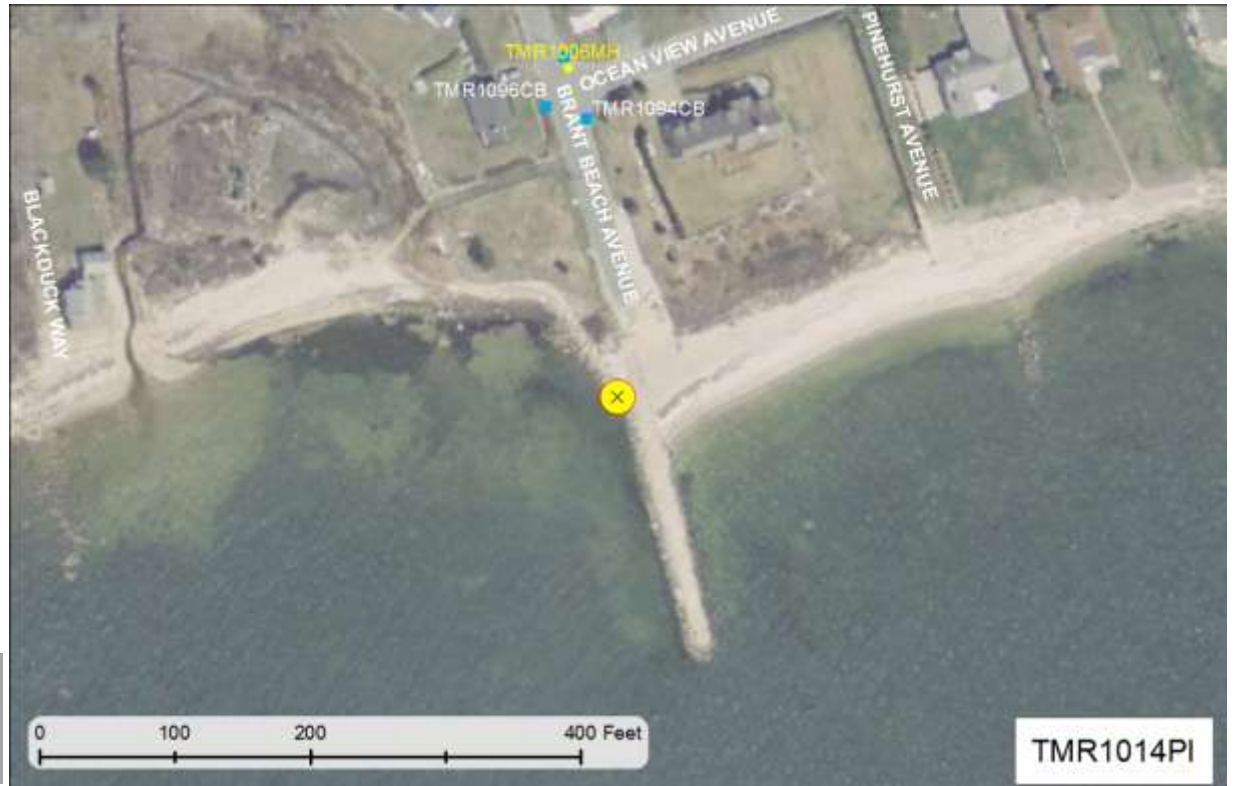
DW: No flow, no issues. WW: One day (2 samples), elevated in all parameters. WW: Rank Bact (2), Amm/Nitrates/Surf (1 ea), Tot 5. Recommend: continue WW samples and begin ID investigation. NB Impair: Bact
